Los Alamos National Laboratory

Memo No: EES1-SH90-17

**RESULTS OF GEOLOGICAL MAPPING
AND FRACTURE STUDIES: TA-55 AREA**

SUBJECT: RESULTS OF GEOLOGICAL MAPPING/FRACTURE STUDIES: TA-55 AREA

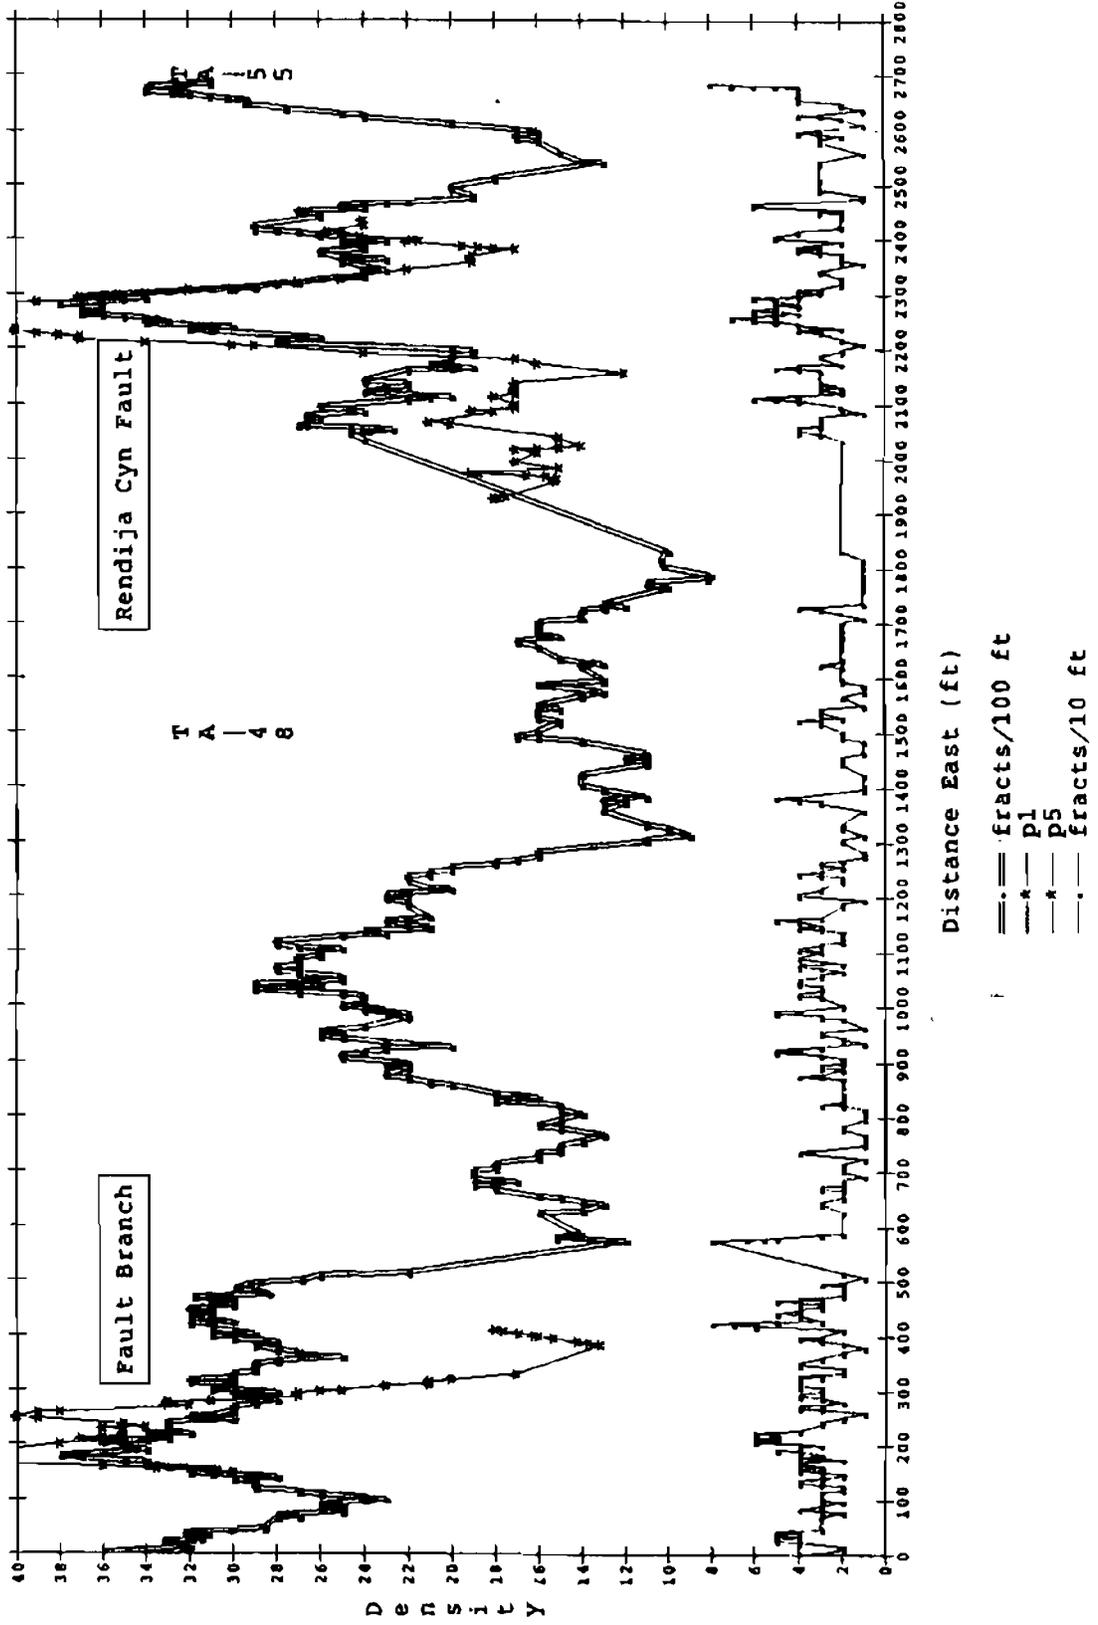
Along Pajarito Road (Figure 4), two peaks occur, one near the old turnoff to TA-48 and one just south of TA-55. The latter of these peaks with values of 25 to 40 fractures per 100-foot interval is along strike of the RCF, while the former on the western part of the line corresponds to a possible fault branch of the RCF that was mapped by alignment of downthrown blocks micrograbens and zipper joints. Figure 4 also shows 100-foot fracture density curves (p1 and p2) measured along corresponding parts of the line at cuts along the other side of the road. These curves show similar trends as the previous curve, which supports the uniqueness of the data in a sense that the linear data likely represents data for an aerial distribution of fractures.

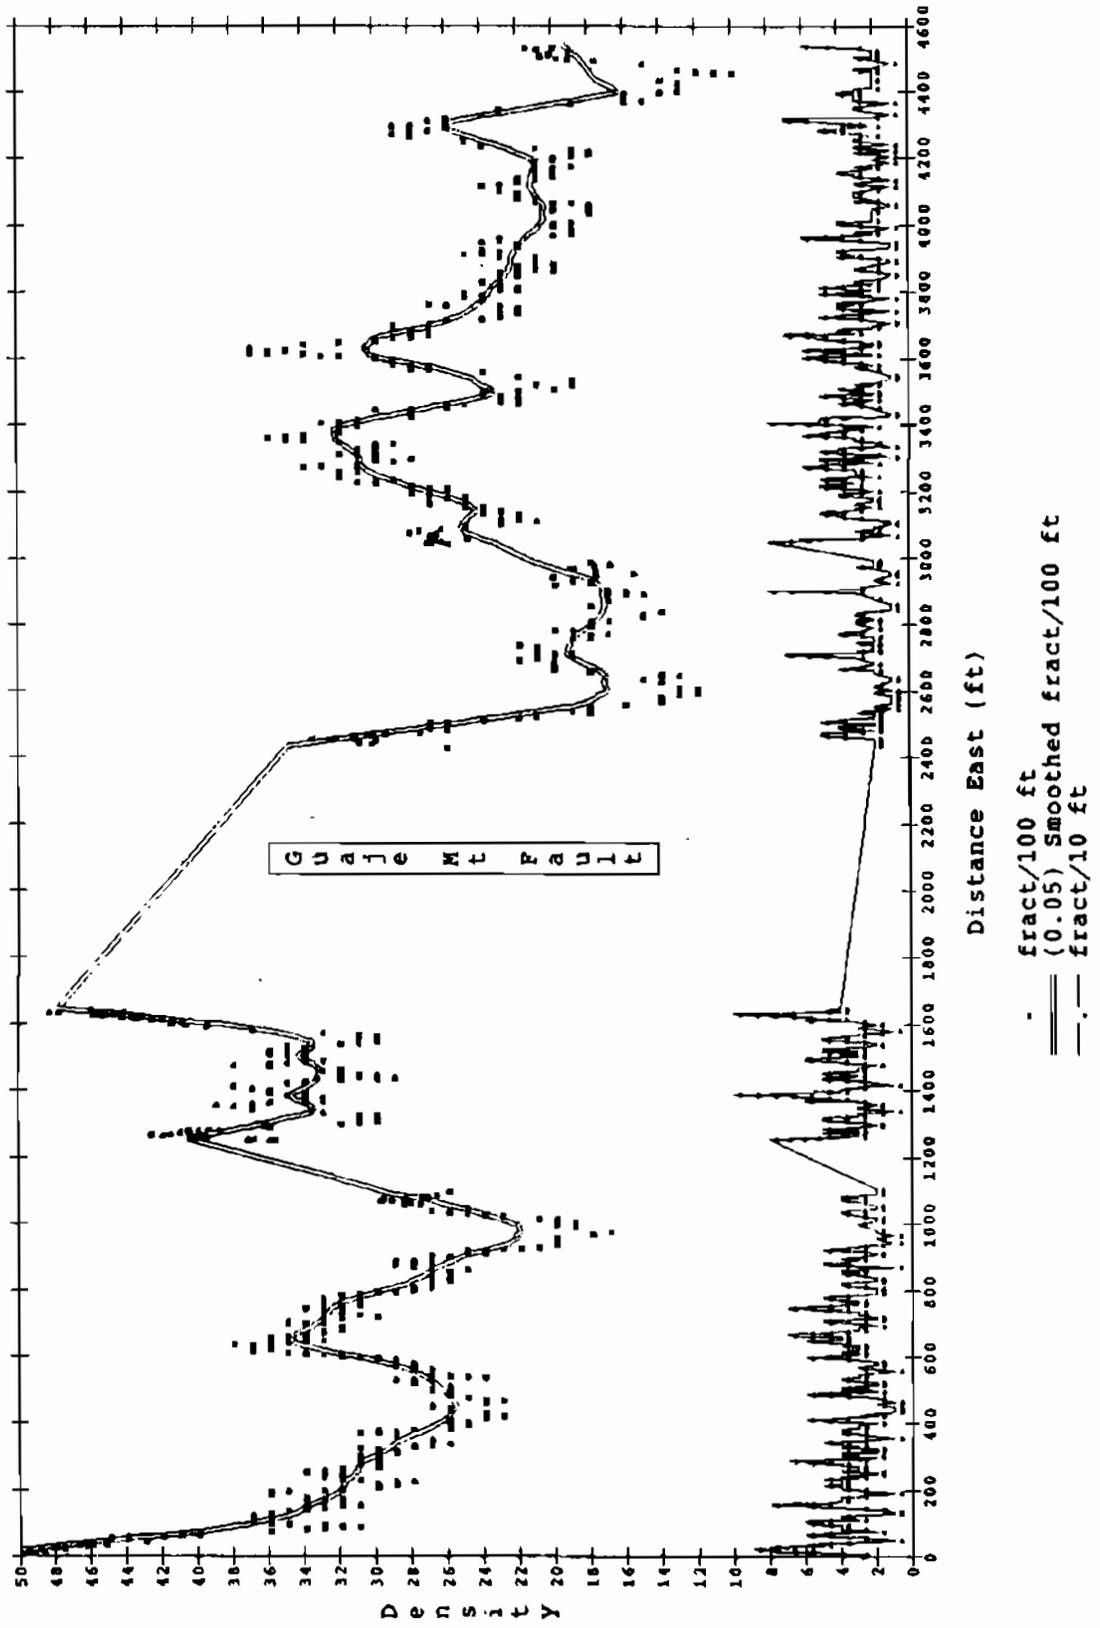
The East Jemez Road line shows two peaks, one at the western edge and an apparent peak between 1,600 and 2,400 ft east where there is also a gap in data because of a lack of a road cut exposure there. This latter peak (24 to 50 fractures per 100-foot interval) corresponds in location to the trace of the GMF. The former peak might reflect the proximity of the RCF, which is projected to be about 1,000 ft west of this line, or possibly a branch fault running west-northwest along the road connecting the RCF and the GMF.

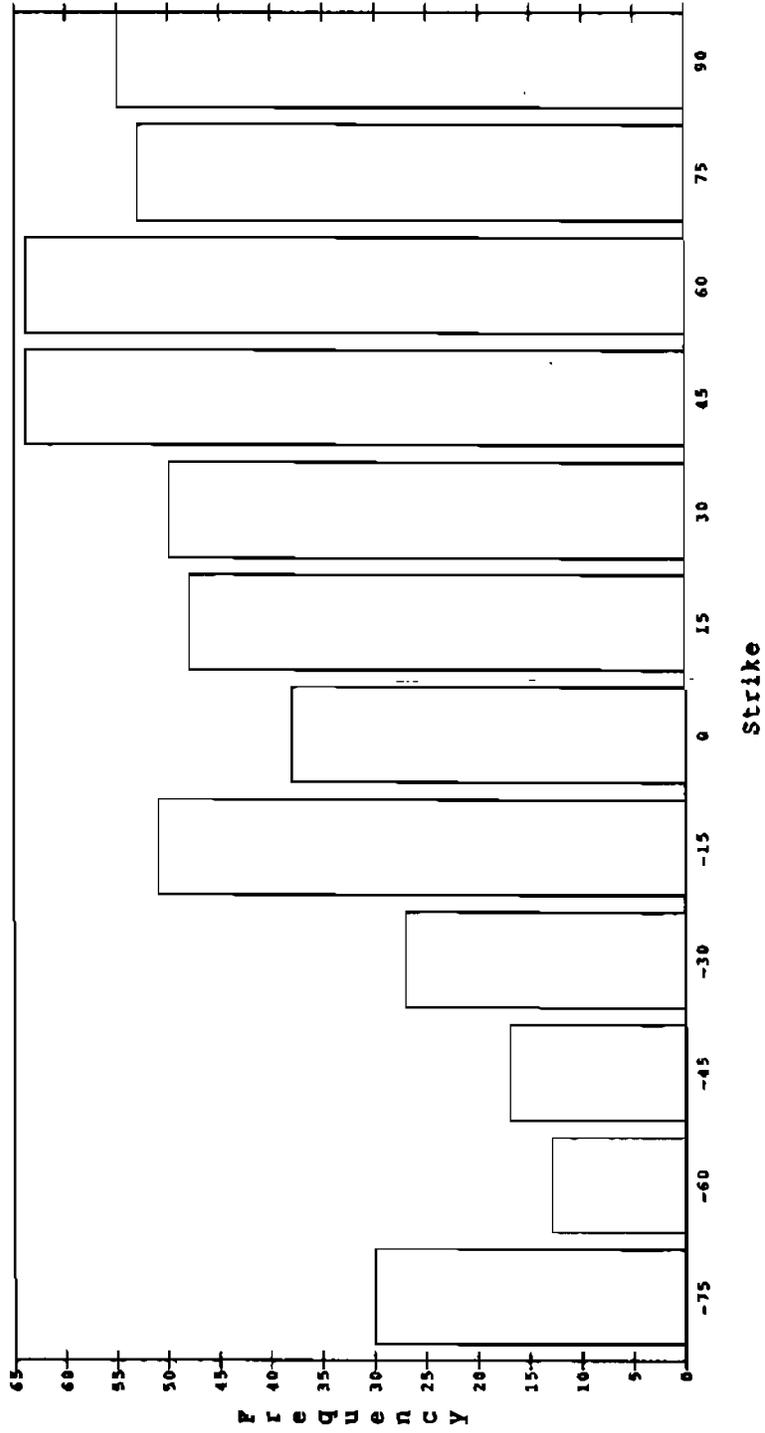
Pajarito Road Fracture Strikes

Histograms of fracture strikes (Figures 6 and 7) show an almost continuous distribution of strikes from -90 degrees (West) north through 0 degrees to 90 degrees (East) with only a slight preference in frequency of fractures trending northeast. These data are illustrated with linear distance in Figures 8 and 9.

Along Pajarito Road, the dominant fracture strike is about N16E with the northeast set averaging around N45E and the northwest set averaging around N39W. There is little apparent variation in fracture strikes across the trace of the RCF (1,900 to 2,400 ft east) and over the fault branch (100 to 500 ft east).

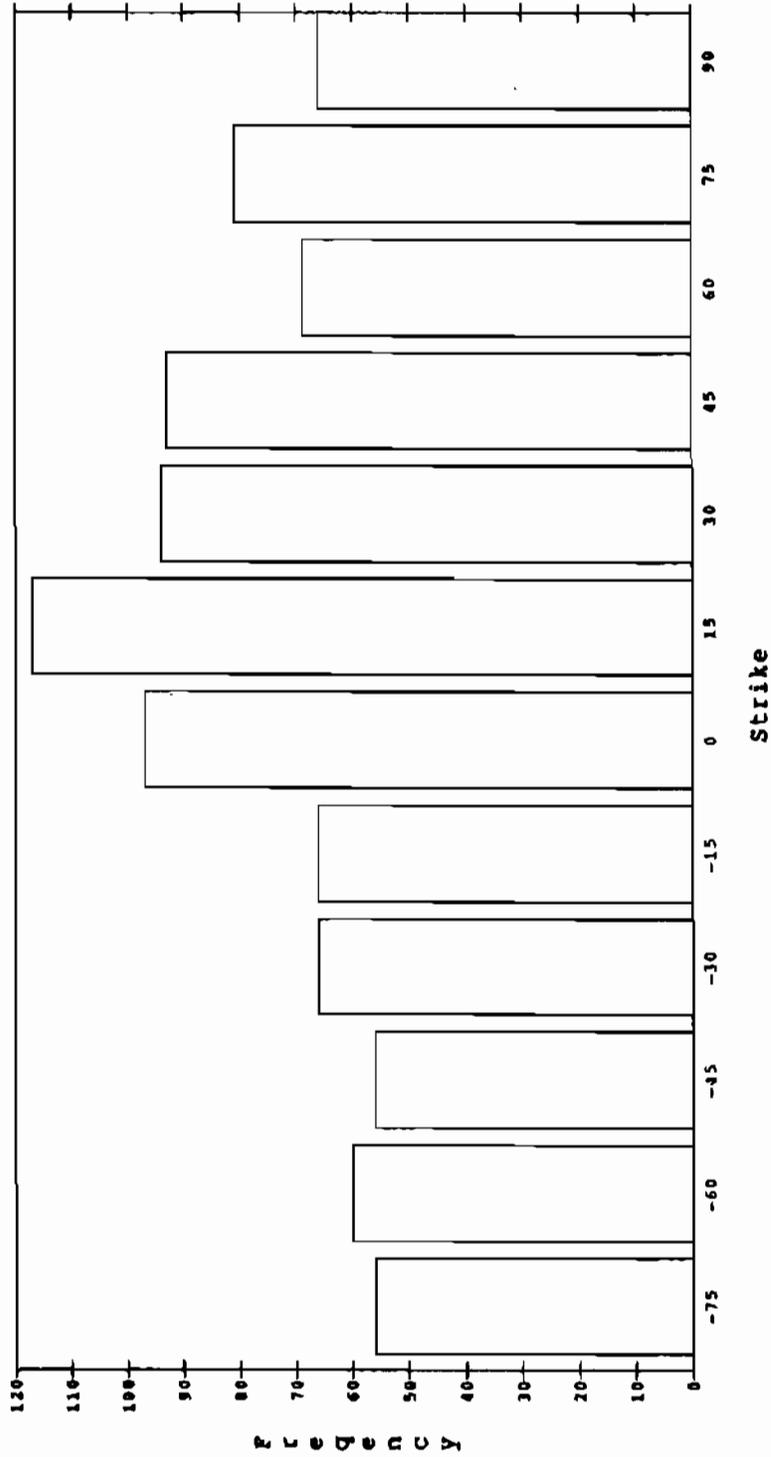
East Jemez Road Fracture Strikes

The East Jemez Road line shows average fracture strikes just 4 degrees east of north with NE fractures averaging N39E and NW fractures averaging N42W. In these data only a change from a dominance of NE fractures to a dominance of NW fractures gives an indication of the presence of the GMF.

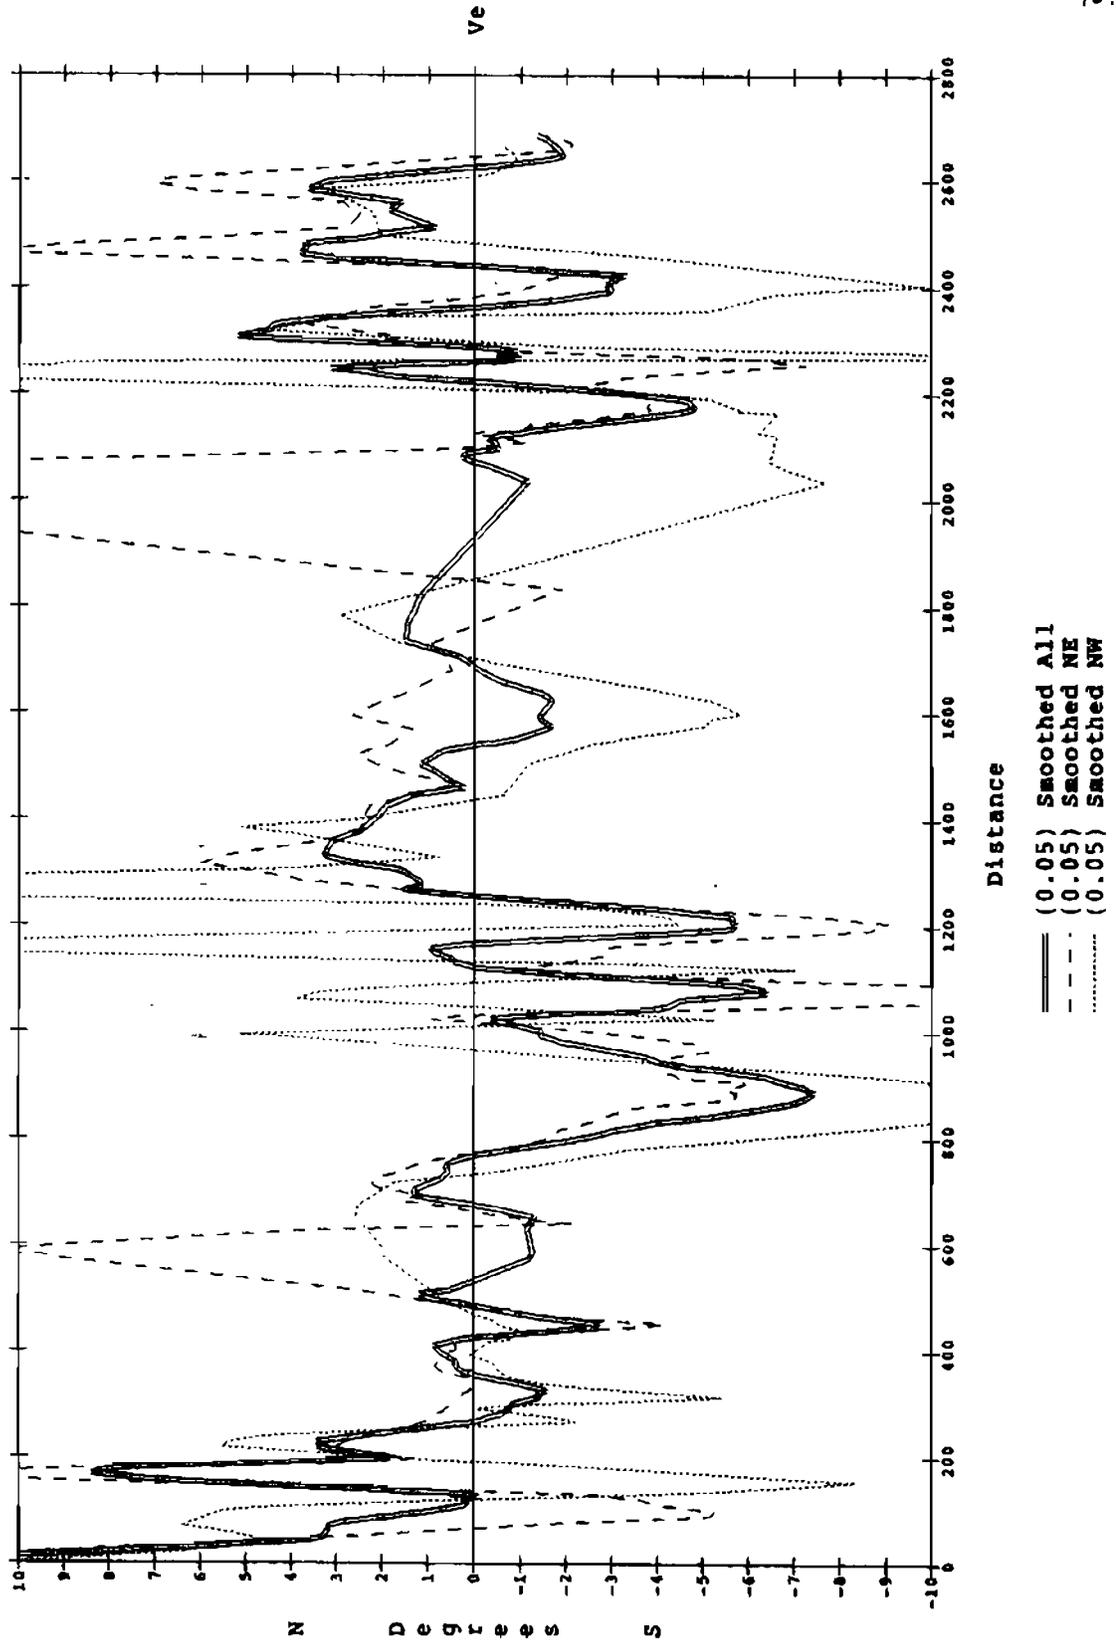
Pajarito Fracture Dips

Fracture dips average 76 degrees (73 along NE sets, 81 along NW sets) on the Pajarito line, and they average uniformly 75 degrees along the East Jemez line. These dips are dominantly 1 to 10 degrees to the northwest or northeast of vertical (80 to 89 degrees) for the fault zones along Pajarito Road (Figure 10), whereas in between these zones the dips are more nearly vertical with a southeast or southwest dipping tendency. Where NE trending fractures dip further from vertical so does the NW set, but in the opposite direction. For the East Jemez Road line (Figure 11), there is no apparent variation in fracture dips across the projection of the GMF.

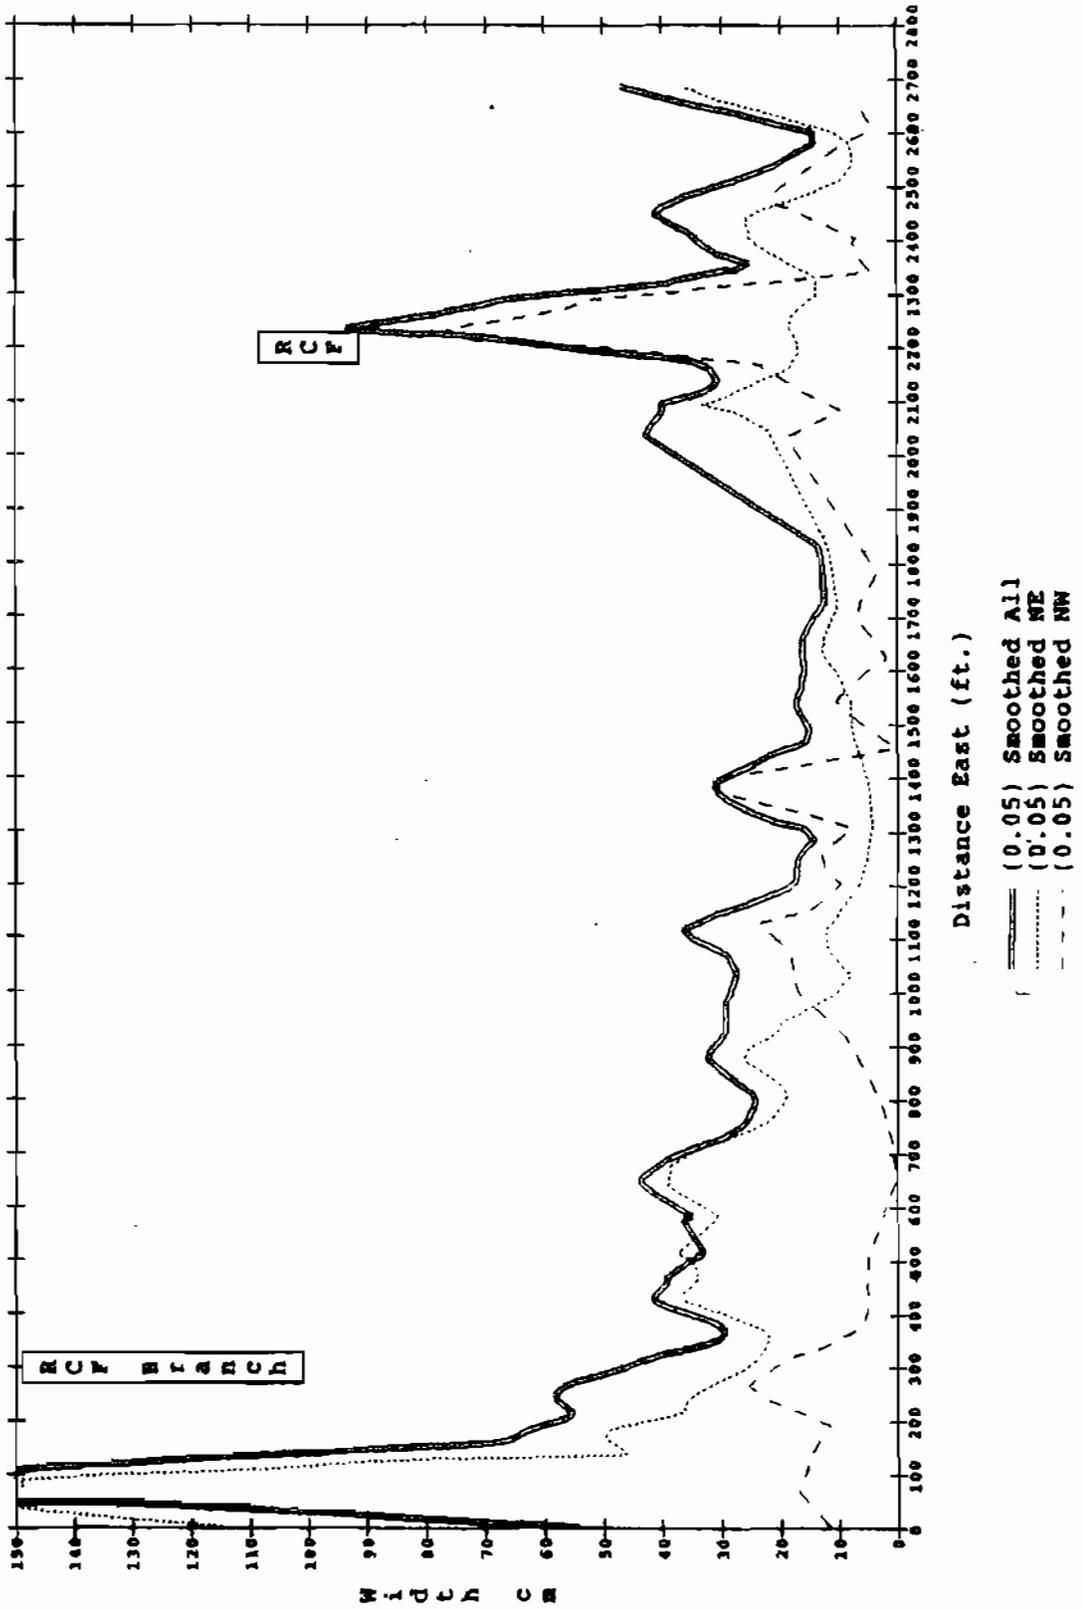
Pajarito Fracture Widths / 100 ft

cumulative fracture opening along this line is 9.06 m, 3.56 m accounted for across the RCF branch and 2.45 m across the RCF. Figure 13 shows fracture opening per 100-foot interval along the Pajarito line, and noticeable peaks occur over projected fault traces. Across the RCF opening of NW fractures is greater than that of NE fractures. The opposite relationship however is apparent across the fault branch, with NE fractures showing the greatest opening.

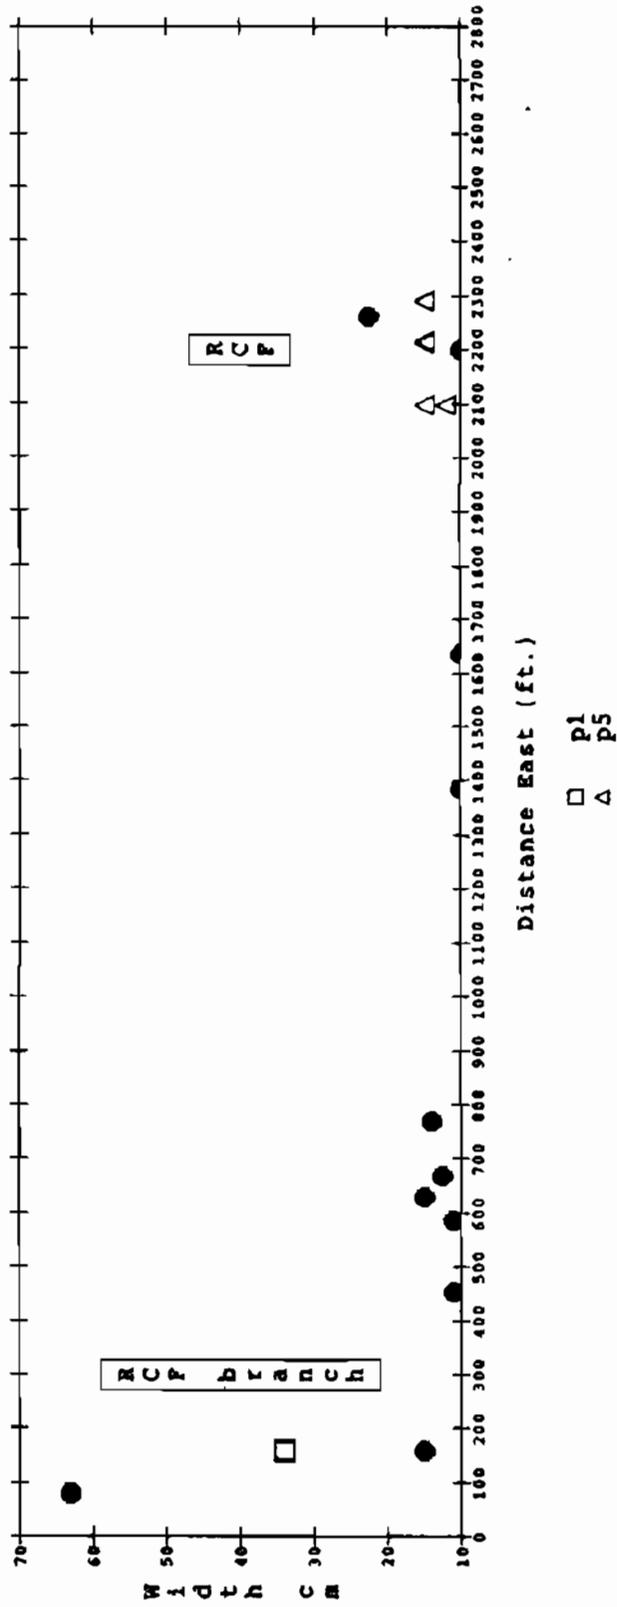
Pajarito Fracture Widths

There are several zones along the Pajarito Road line of notable fracture openings where fractures are filled with or adjacent to brecciated rock and possibly gouge. Figure 14 shows the locations and openings of fractures that are filled with over 10 cm of breccia or detritus for the Pajarito Road line. There are noticeable occurrences over the RCF and the RCF branch. Specific examples over the RCF branch include fracture number 22 (Plate 2, section P2A), which consists of two fractures separated by 1.26 m of detrital fill and breccia, fracture 43 (Plate 2, section P2A) with an opening of 15 cm filled with breccia, and fracture 4 (Plate 2, section P1), which is two fractures separated by a 68 cm wide zone of rubble, and a zone of completely broken tuff 2 m wide but with no measurable fracture surfaces between fractures 6 and 7 (Plate 2, section P3A). Possible fault breccia and gouge zones over RCF exist between fracture 5 and 6 (Plate 2, section P4A), between fractures 54 and 68 (Plate 2, section P4A), and between fractures 83 and 88 (Plate 2, section P4B). Across Pajarito Road from sections P4A and P4B, a brecciated zone 90 cm wide exists between fractures 5 and 6 (Plate 2, section P5A), another breccia zone over 1 m wide exists between fractures 23 and 26 (Plate 2, section P5A), fracture 39 (Plate 2, section P5B) has 15 cm of breccia fill, and a breccia zone between fractures 64 and 65 (Plate 2, section P5B) has 5 parallel fractures in a crumbled zone about 1 m wide. These zones on section P5A and P5B correlate in relative location to zones identified in sections P4A and P4B.

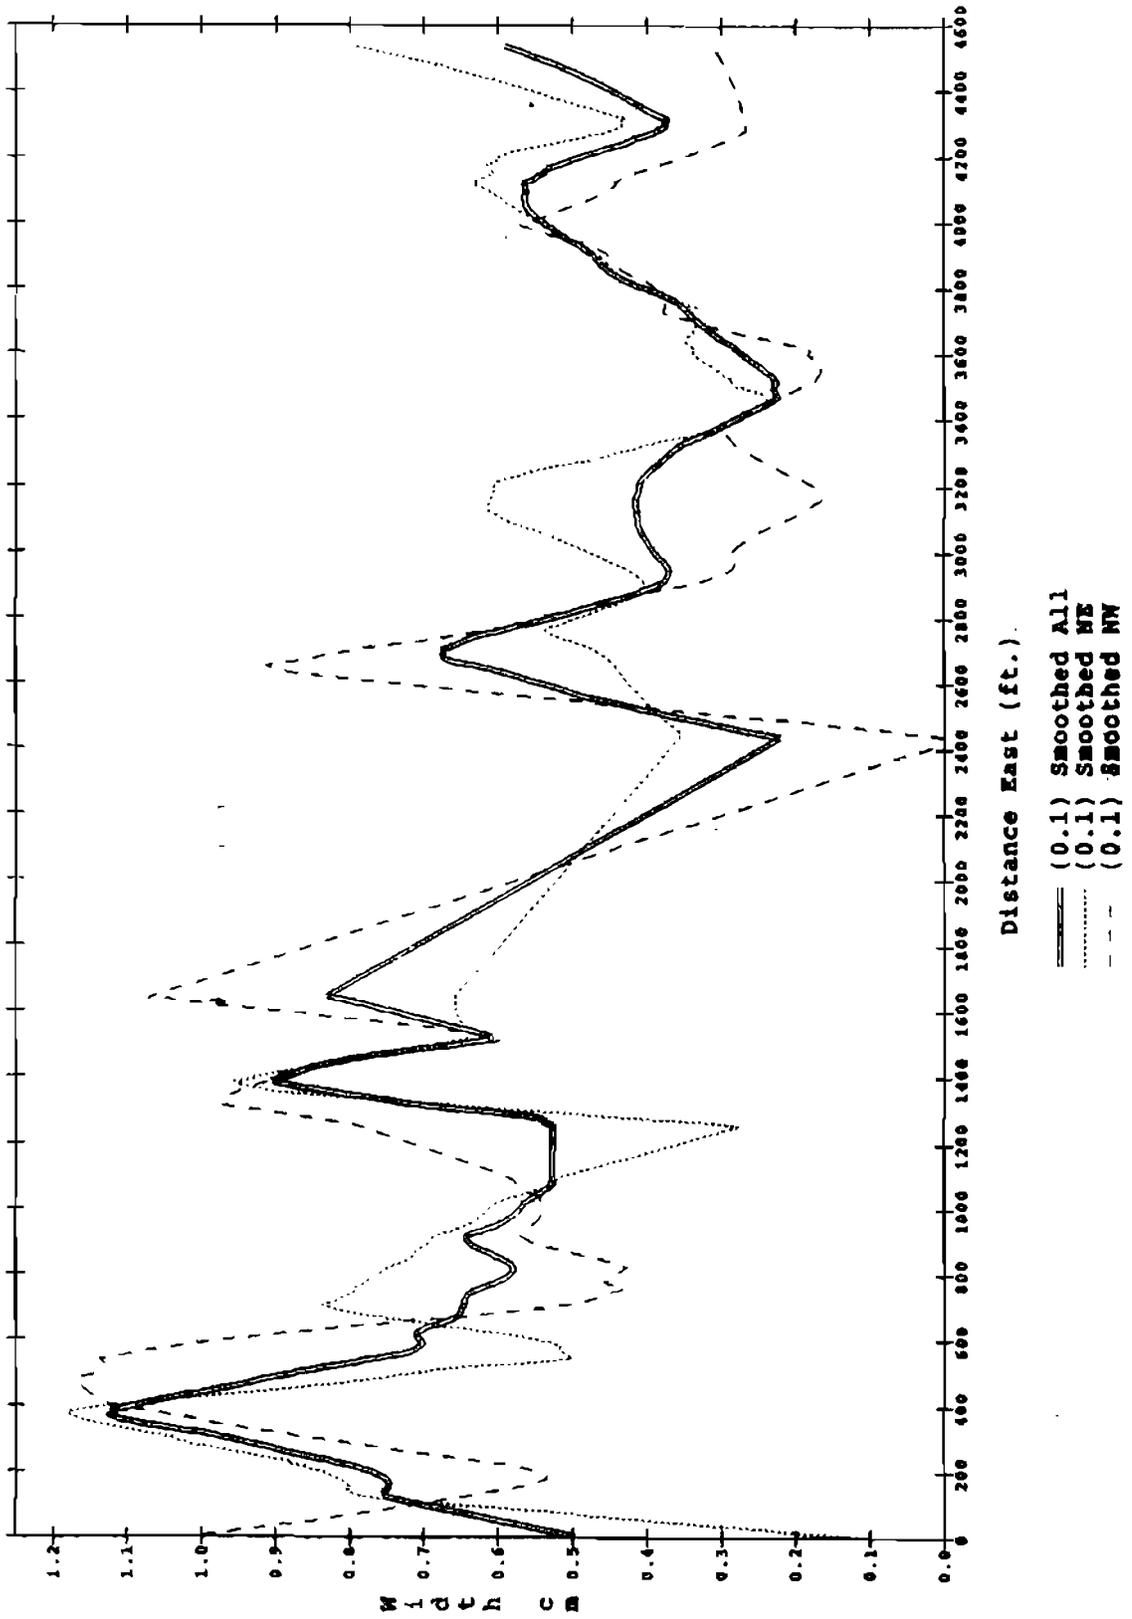
Figure 15

Along the East Jemez Road line, average fracture opening widths (Figure 15) are about 0.9 cm. There is an apparent decrease in width to about 0.4 cm in crossing the GMF from west to east. In general NW fractures are opened slightly more than NE ones, although for the cumulative fracture opening along this line of 8.51 m, 5.25 m is accommodated by the NE set while only 3.26 m is due to the NW set (Table 2), because there are fewer NW fractures than NE ones. Figure 16 shows fracture opening per 100-foot

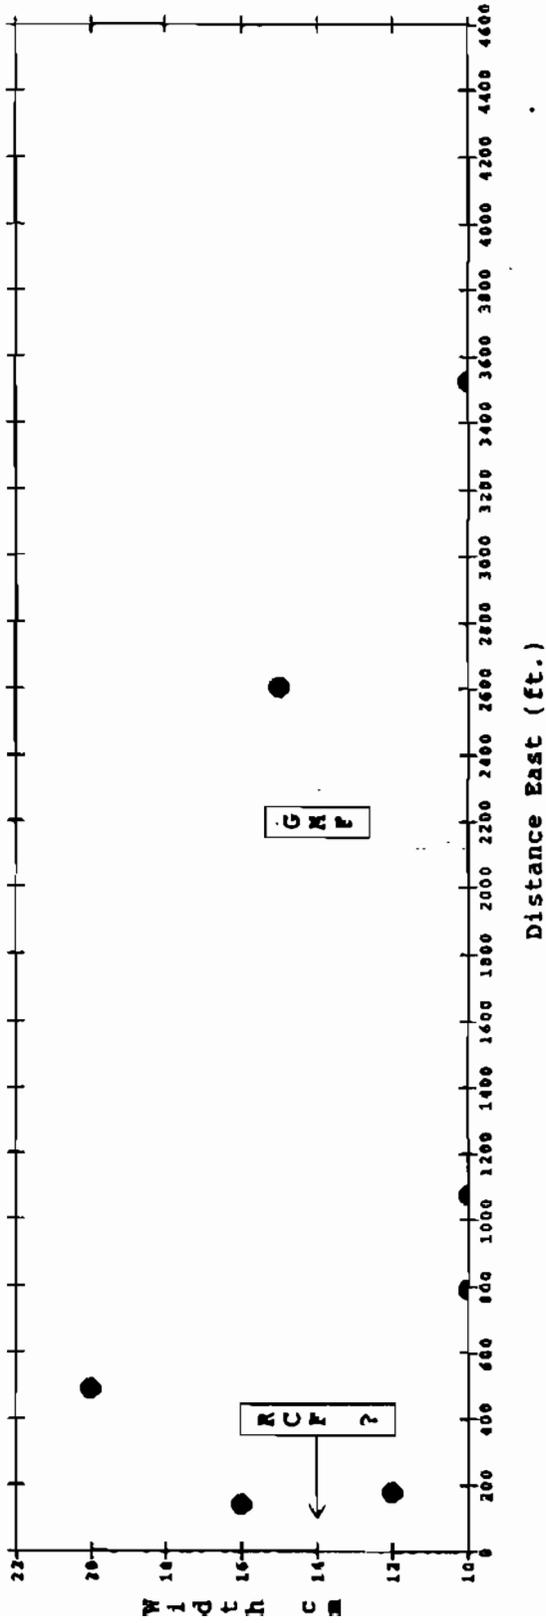
East Jemez Fracture Widths

Along East Jemez Road (Figure 17) only one fracture opening greater than 10 cm was noted over the trend of the GMF while several were noted on the west end of the line, possibly a response to the proximity of the RCF. These fractures are noted as fractures 54, 67, and 69 (Plate 3, section E1A) and fracture 36 (Plate 3, section E3A).
