Collision of Norfolk Southern Freight Train 192 With Standing Norfolk Southern Local Train P22 With Subsequent Hazardous Materials Release at Graniteville, South Carolina
January 6, 2005

Railroad Accident Report

NTSB/RAR-05/04

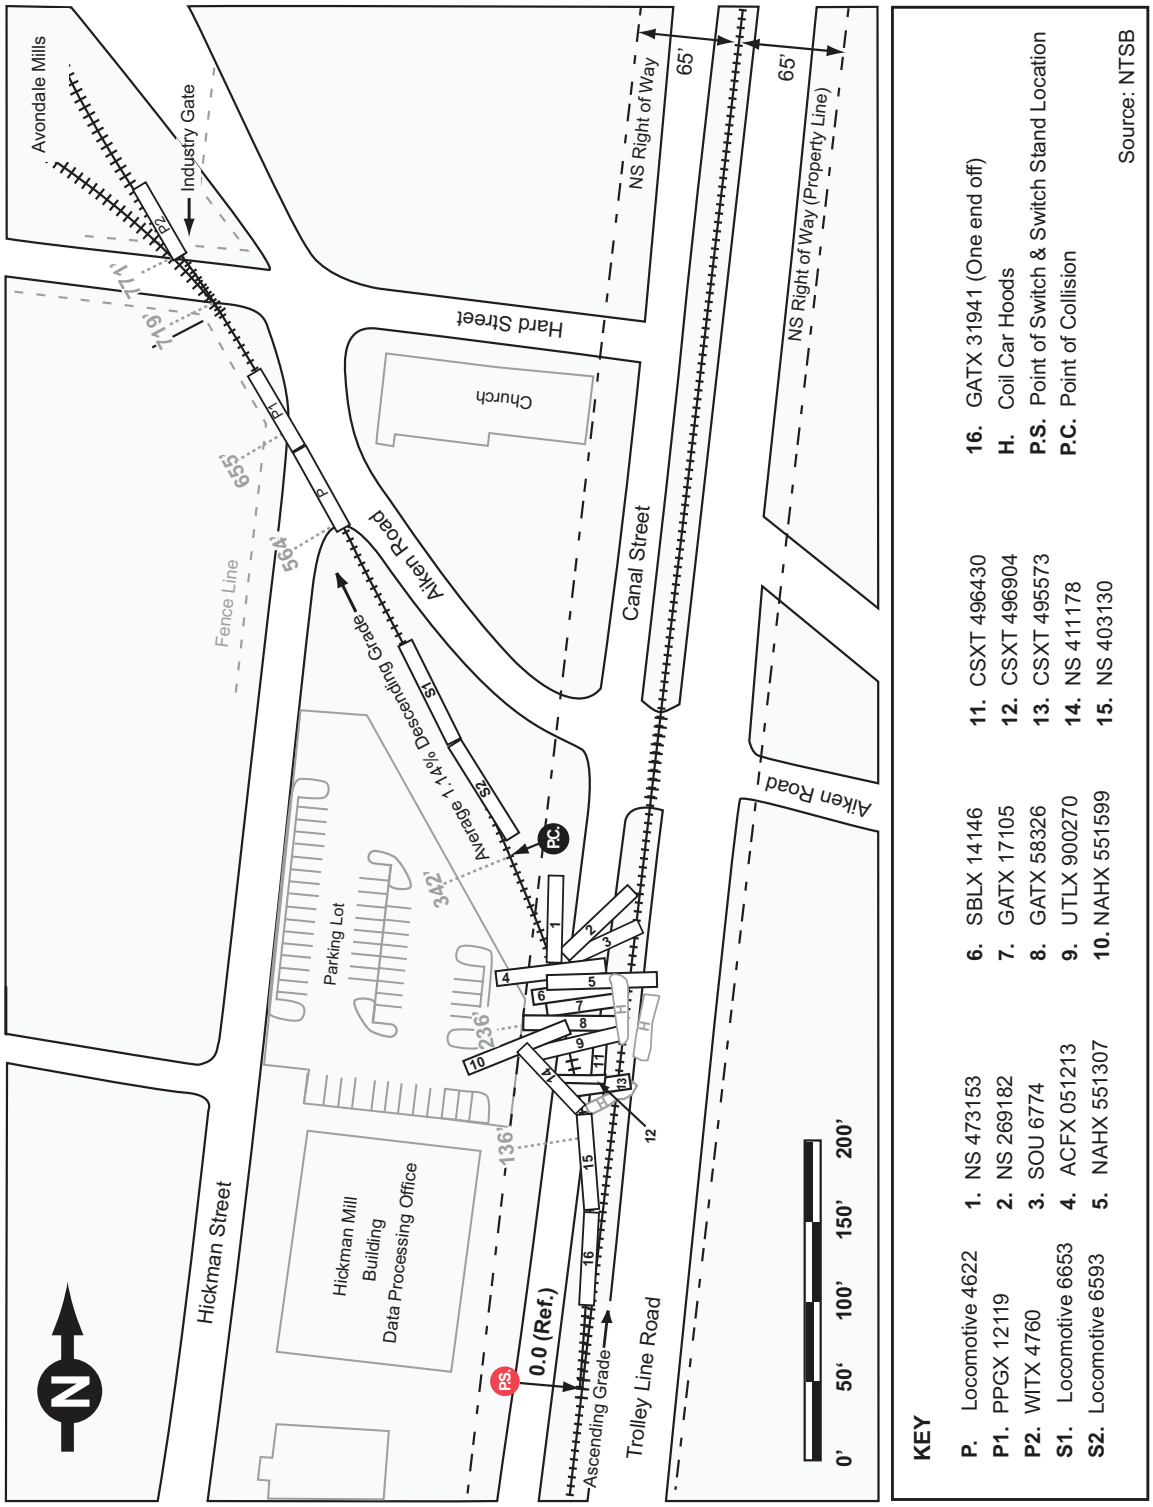
Figure 7. Distribution of wreckage after the derailment and collision. "P.C." indicates estimated point of collision

Wreckage and debris of the derailed railroad equipment extended more than 500 feet, beginning at the industrial turnout switch and continuing in a northerly direction along the industry track. Investigators were not able to perform a detailed documentation of the wreckage because of the continuing potential of a hazardous gas release and because of the wreckage cleanup efforts that prevented access to the site.
