RS 2131/86

POST-MORTEM EXAMINATION OF MK 28 COMPONENTS FROM THE PALOMARES, SPAIN ACCIDENT (CRD)

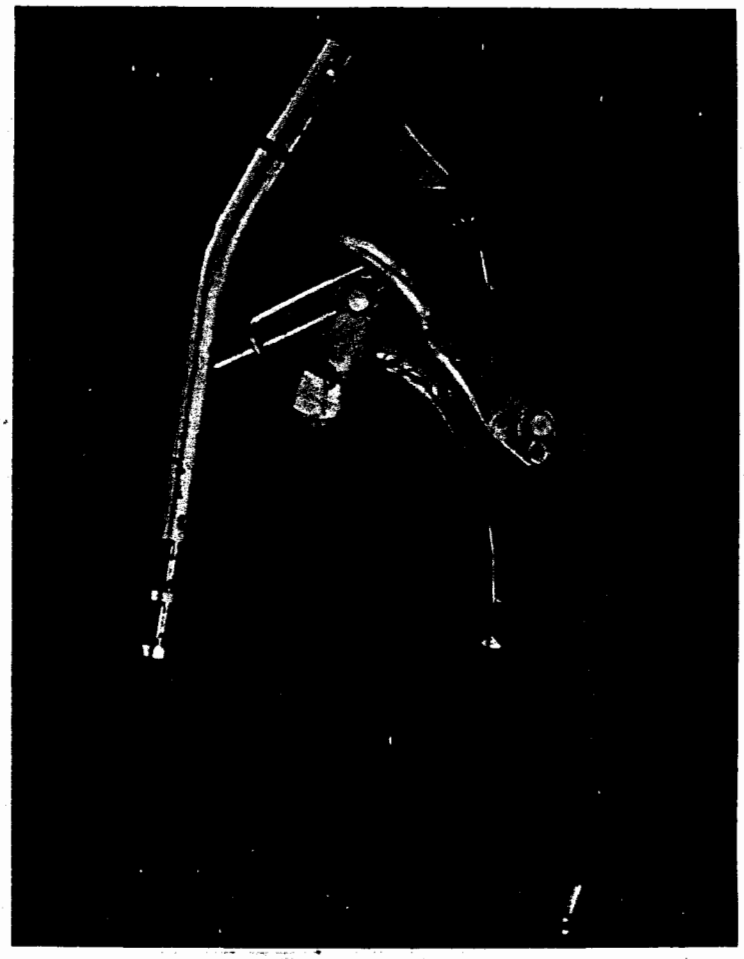
FIGURE 1

MC1120 Single Pulse Generator Serial Number BBN6909A3 -- The MC1120 was received with one pullout rod withdrawn and bent. (See Appendix Figure 1.) No other deficiencies were evident. A spare pullout rod was inserted in lieu of the bent one.

Pullout Rod from MC1120
S/N BBN 6909A3

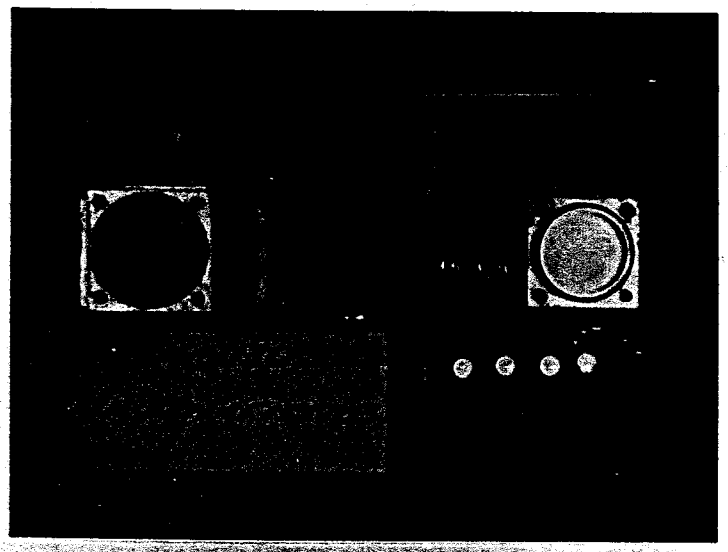
FIGURE 12

All four MC1136's were then disassembled and interior subcomponents examined. One MC1136 contained no interior corrosion. One had only a trace of interior corrosion. Two (see Appendix Figure 12) had extensive interior corrosion.

4. Two of the MC1136's showed extensive internal corrosion implying failure of seals.

MC1136 S/N BBN15155D3 & BBN15340D3

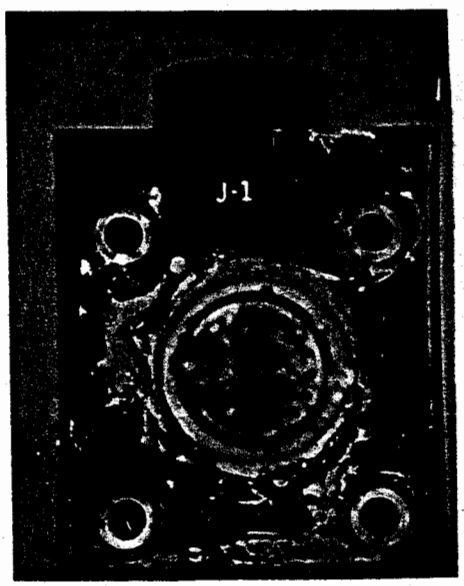
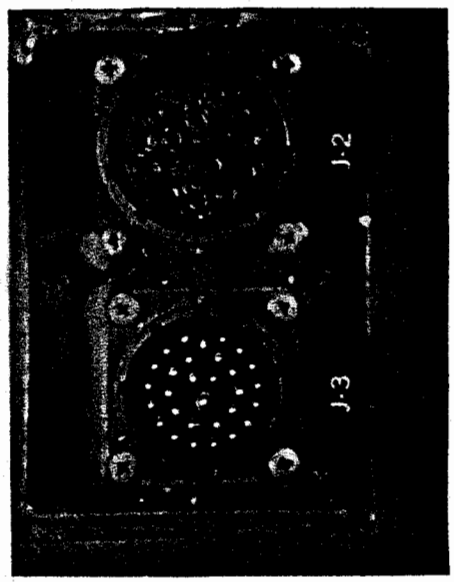
FIGURE 17

MC1454 S/N BBN2491D3

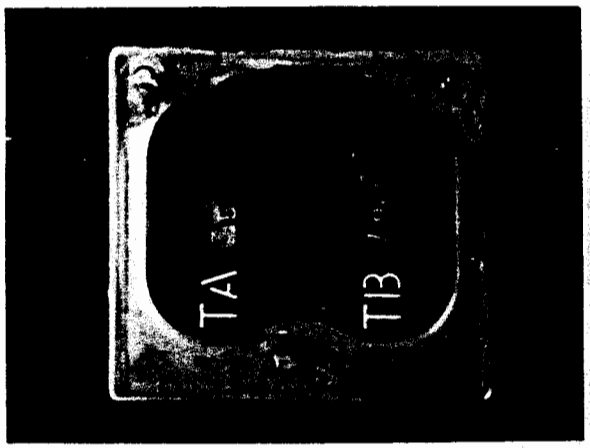
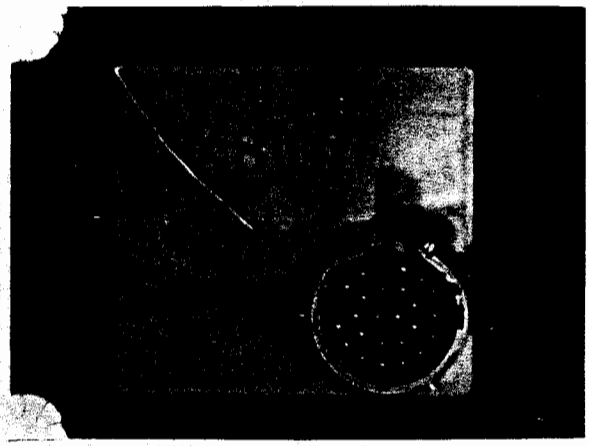
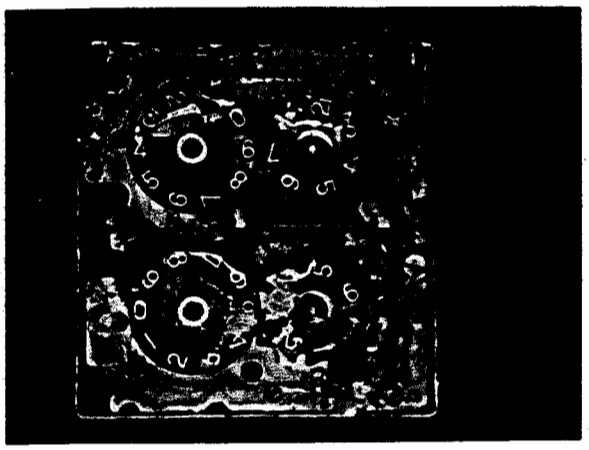
MC1469 S/N BAN 2888C3

MC1469 Sequential Timer Serial Number BAN2888C3 -- Examination revealed that both MC1320 Explosive Motors had been activated. The outer case was corroded and internal salt deposits could be seen in the windows. When the case was removed, extensive salt deposits and corrosive areas were found. Salt water had entered the case through the shaft opening for TB time setting knob. Galvanic action between dissimilar metals had occurred. Channel 1 fixed time interval printed circuit board came loose from the gear. The lands were coming loose and the board was blistered in four places on Channel 2 fixed time interval printed circuit board. All brass subcomponents had turned black. One production workmanship defect was found; the retaining ring for the TA Knob was not seated. Photographs of exterior and interior conditions are shown in the Appendix Figures 18, 19 and 20.

Top Cover

Bottom Cover

Inside Top Cover

Setting Indicators & Top Plates
