Collision of Norfolk Southern Freight Train 192 With Standing Norfolk Southern Local Train P22 With Subsequent Hazardous Materials Release at Graniteville, South Carolina
January 6, 2005

Railroad Accident Report

NTSB/RAR-05/04

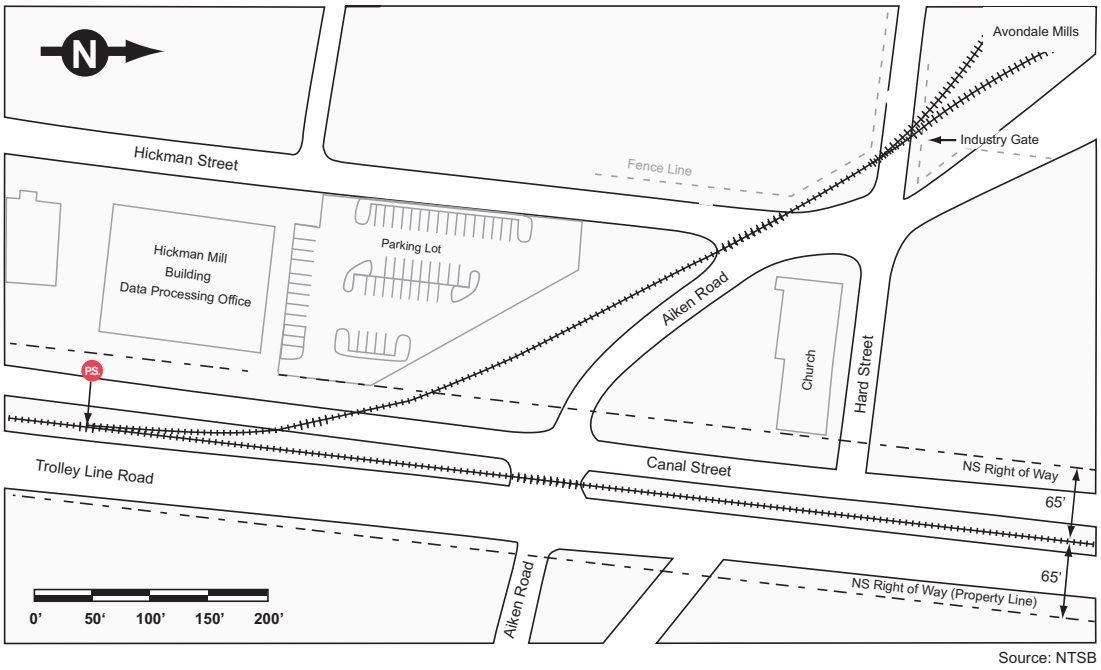
The industry track where the accident occurred serves facilities of Avondale Mills, Inc., a manufacturer of textiles. (See figure 2.) The facilities include the mill's Woodhead, Hickman, and Gregg Division plants as well as the Stevens steam plant. The Avondale Mills industry track (hereinafter referred to as "industry track"), upon diverging from the NS main line, immediately traverses Canal Street at a roadway at-grade crossing and

Figure 2. NS main line and Avondale Mills facility industry track in Graniteville. "P.S." identifies the point of switch from the main line onto the industry track.

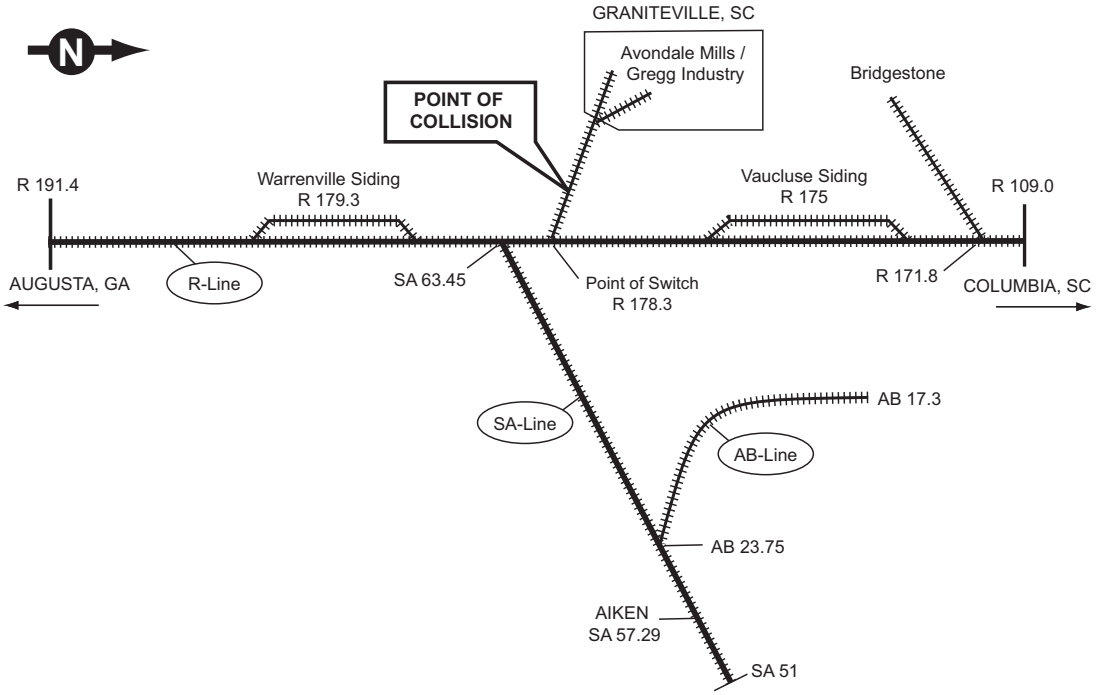
The NS trackage in this area is non-signaled, and authority to use various track segments is via track warrants issued by the train dispatcher in Greenville, South Carolina. At 8:11 a.m., the train P22 conductor was given a track warrant authorizing train P22 to occupy and work on the east-west main line (designated the SA line) between milepost (MP) SA51.0 and Warrenville, South Carolina (MP SA63.4). The SA main line connects Aiken with the north-south main line (designated the R line) on which the accident occurred. (See figure 3.)

Figure 3. NS main lines in the accident area. Mileposts are referenced by letter and number designations.
