Suggested Practices for Avian Protection On Power Lines:

The State of the Art in 2006

Avian Power Line Interaction Committee

PIER FINAL PROJECT REPORT CEC-500-2006-022

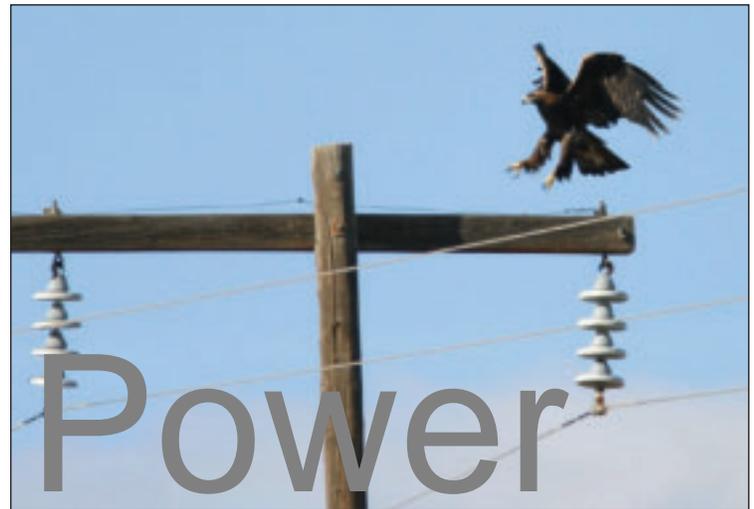
FIGURE 2.2: Golden eagle landing on avian-safe pole. Early research on avian electrocutions and pole modifications focused heavily on golden eagles.

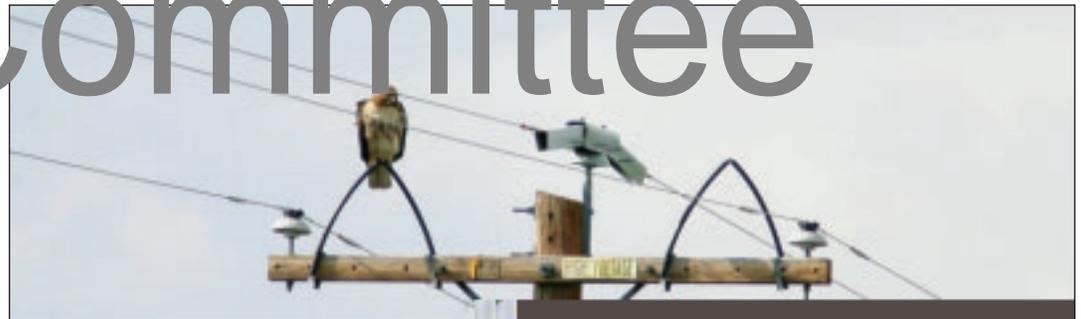
FIGURE 2.5: Perch discouragers have been installed on utility poles to prevent raptors or corvids from preying upon sensitive species. However, this is not recommended, as perch discouragers are intended to manage where birds perch, not to entirely prevent perching.

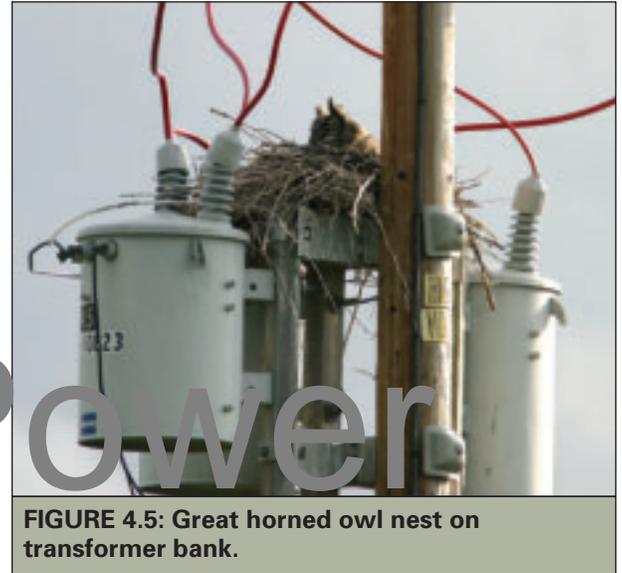
FIGURE 4.5: Great horned owl nest on transformer bank.

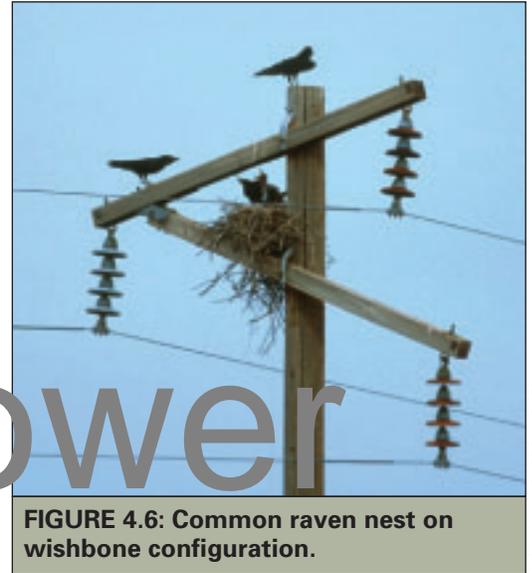
FIGURE 4.6: Common raven nest on wishbone configuration.

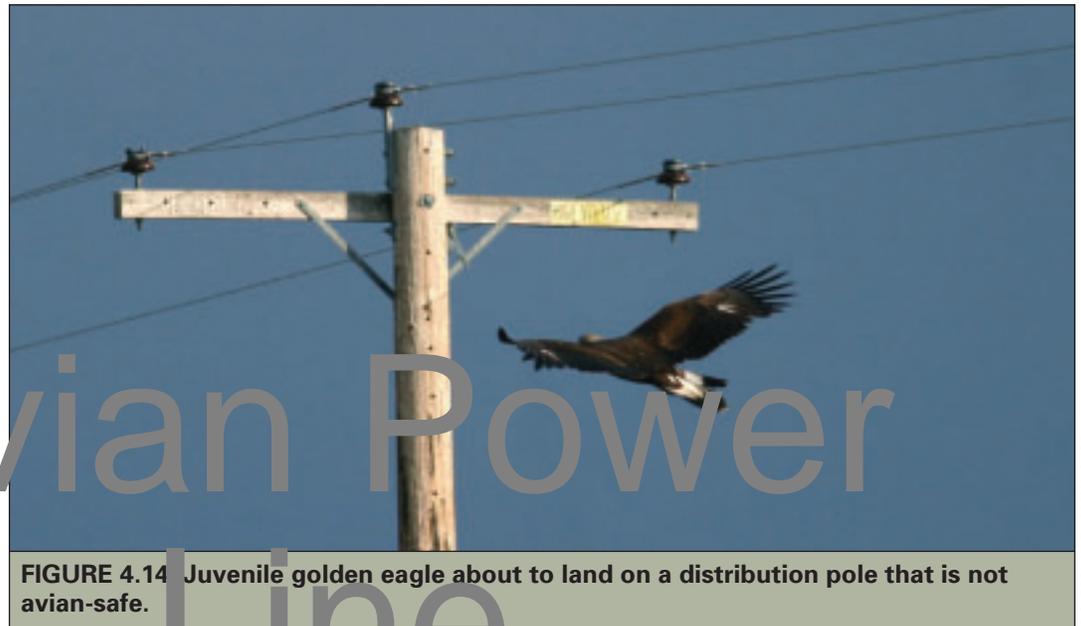
FIGURE 4.14 Juvenile golden eagle about to land on a distribution pole that is not avian-safe.

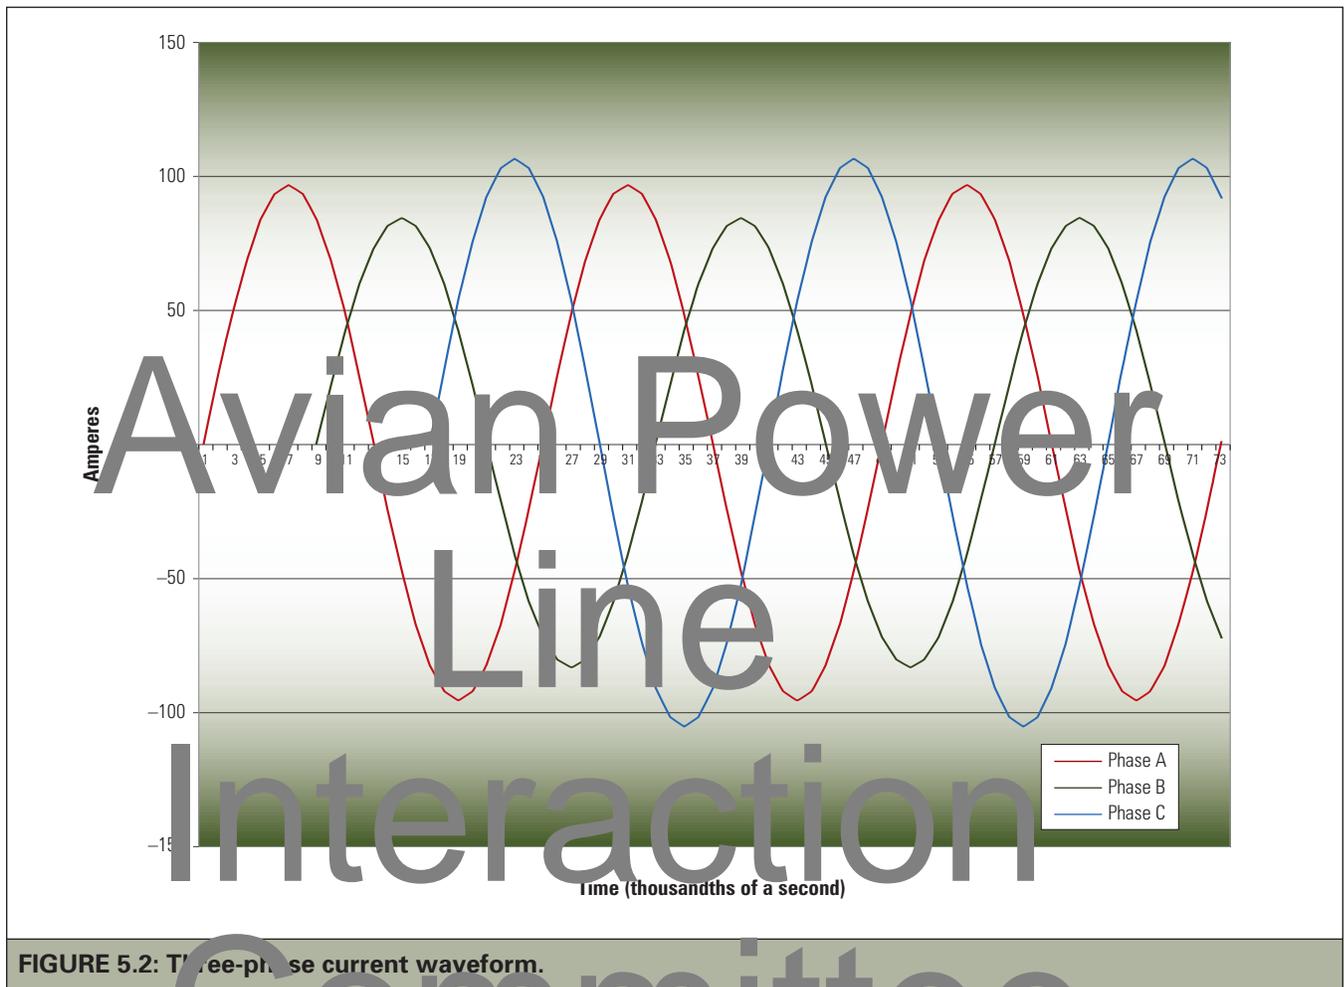
FIGURE 5.2: Three-phase current waveform.

going from zero amperes to a peak ampere value and back to zero amperes. It then reverses direction and for another 1/120th of second flows in the opposite direction in system conductors, again going from zero amperes to a peak magnitude and back to zero amperes. It then changes direction again and the cycle repeats. If projected on a graph, the current would appear as a sinusoidal curve as depicted in Figure 5.2, that shows at least two complete cycles of current flow on phases A, B, and C of a three-phase circuit. In the United States, there are 60 such cycles each second (also referred to as 60 hertz). There are more AC systems than DC systems because utilities can transmit large amounts of power over long distances on high voltage transmission lines and can take advantage of the alternating magnetic fields associated with AC systems.

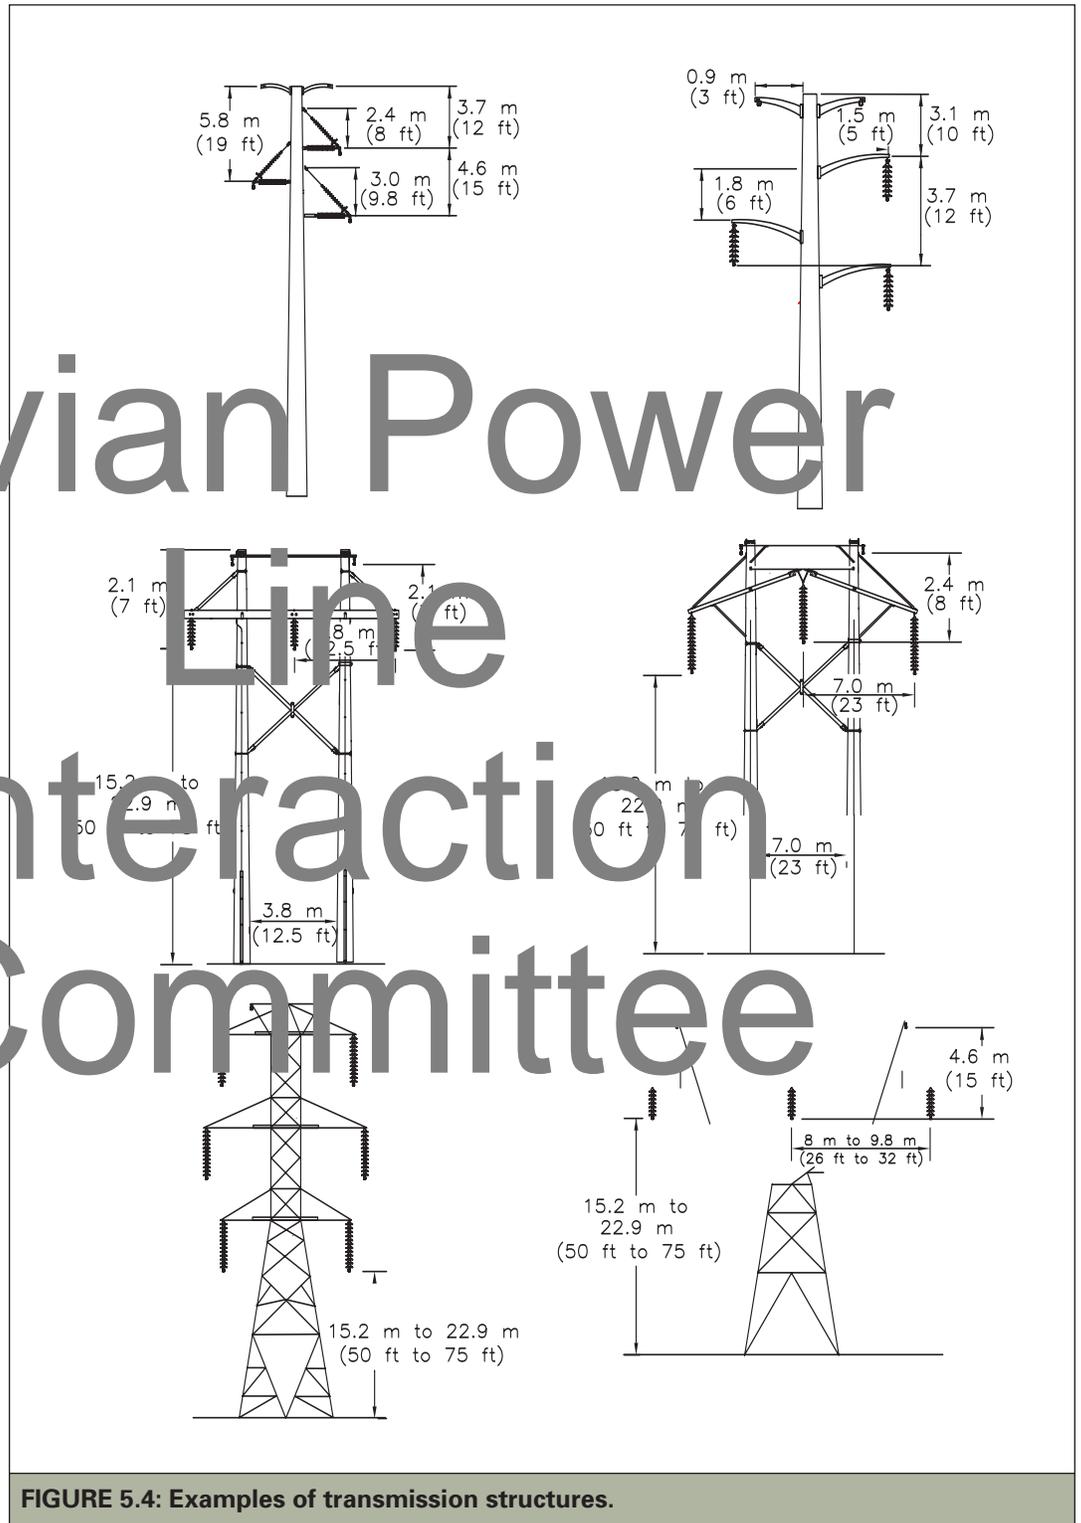
FIGURE 5.4: Examples of transmission structures.

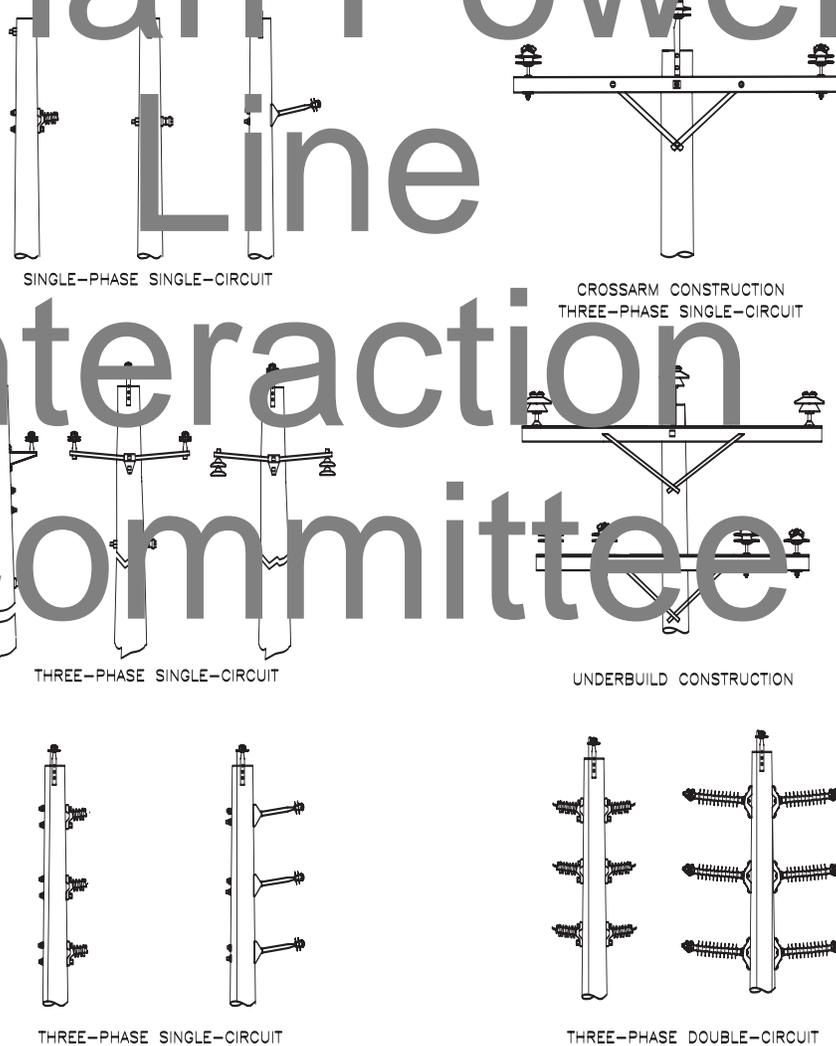
FIGURE 5.5: Examples of typical distribution configurations.

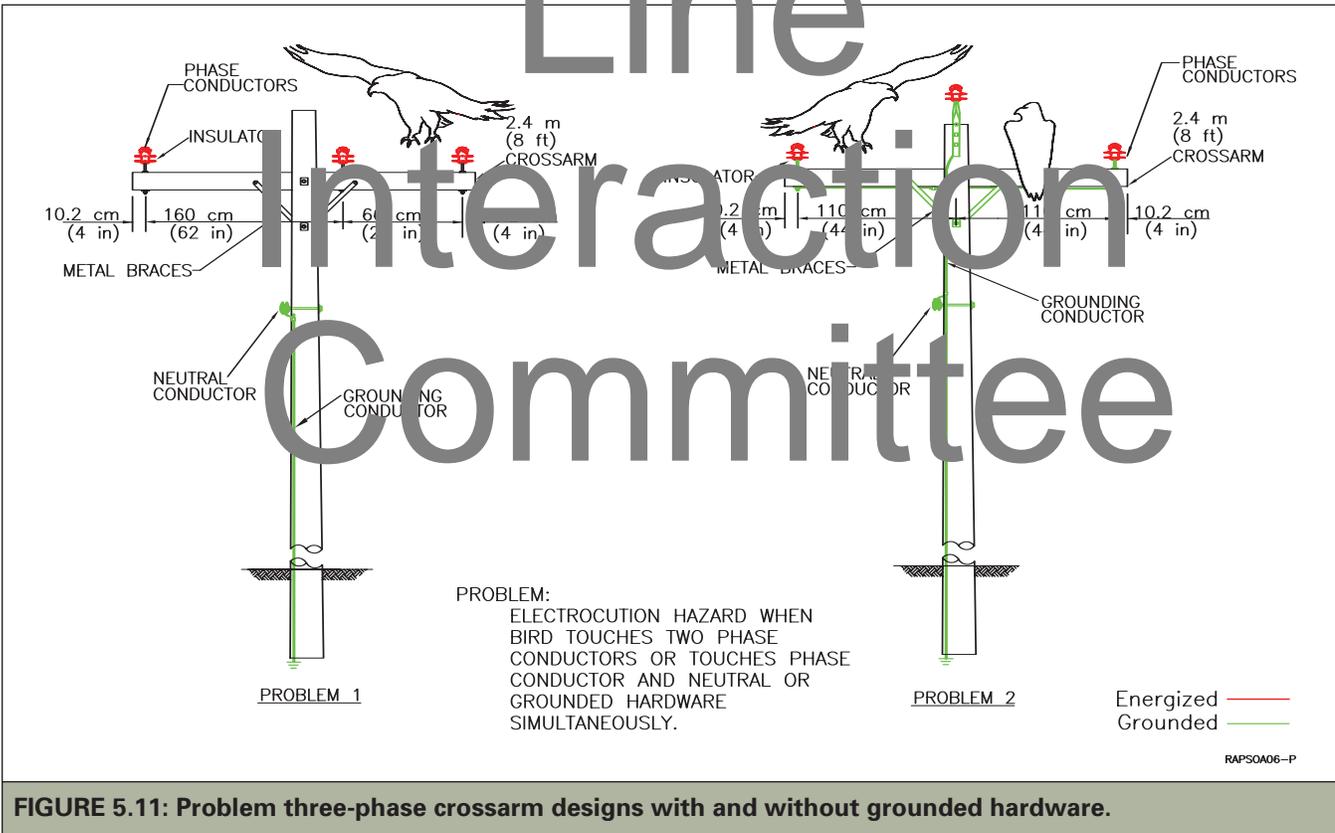
FIGURE 5.11: Problem three-phase crossarm designs with and without grounded hardware.

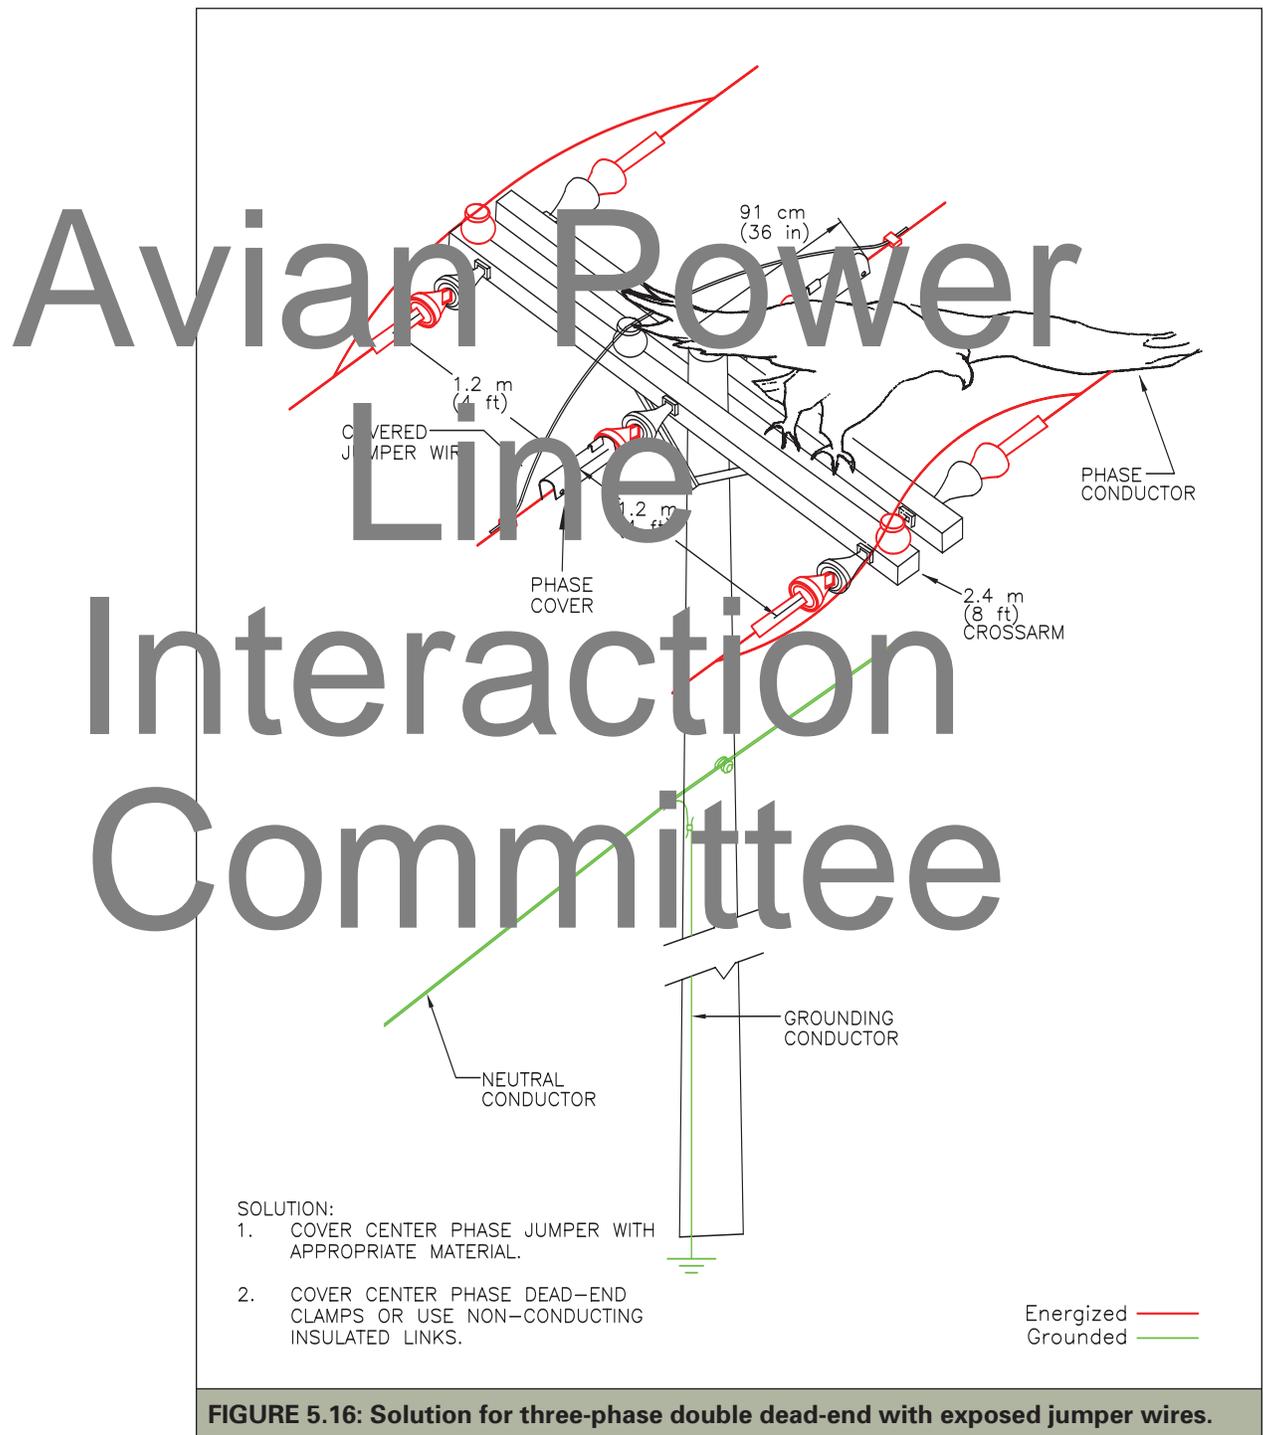
FIGURE 5.16: Solution for three-phase double dead-end with exposed jumper wires.

can insulated links or insulators that move the energized conductor 91 cm (36 in) from the center of the pole.

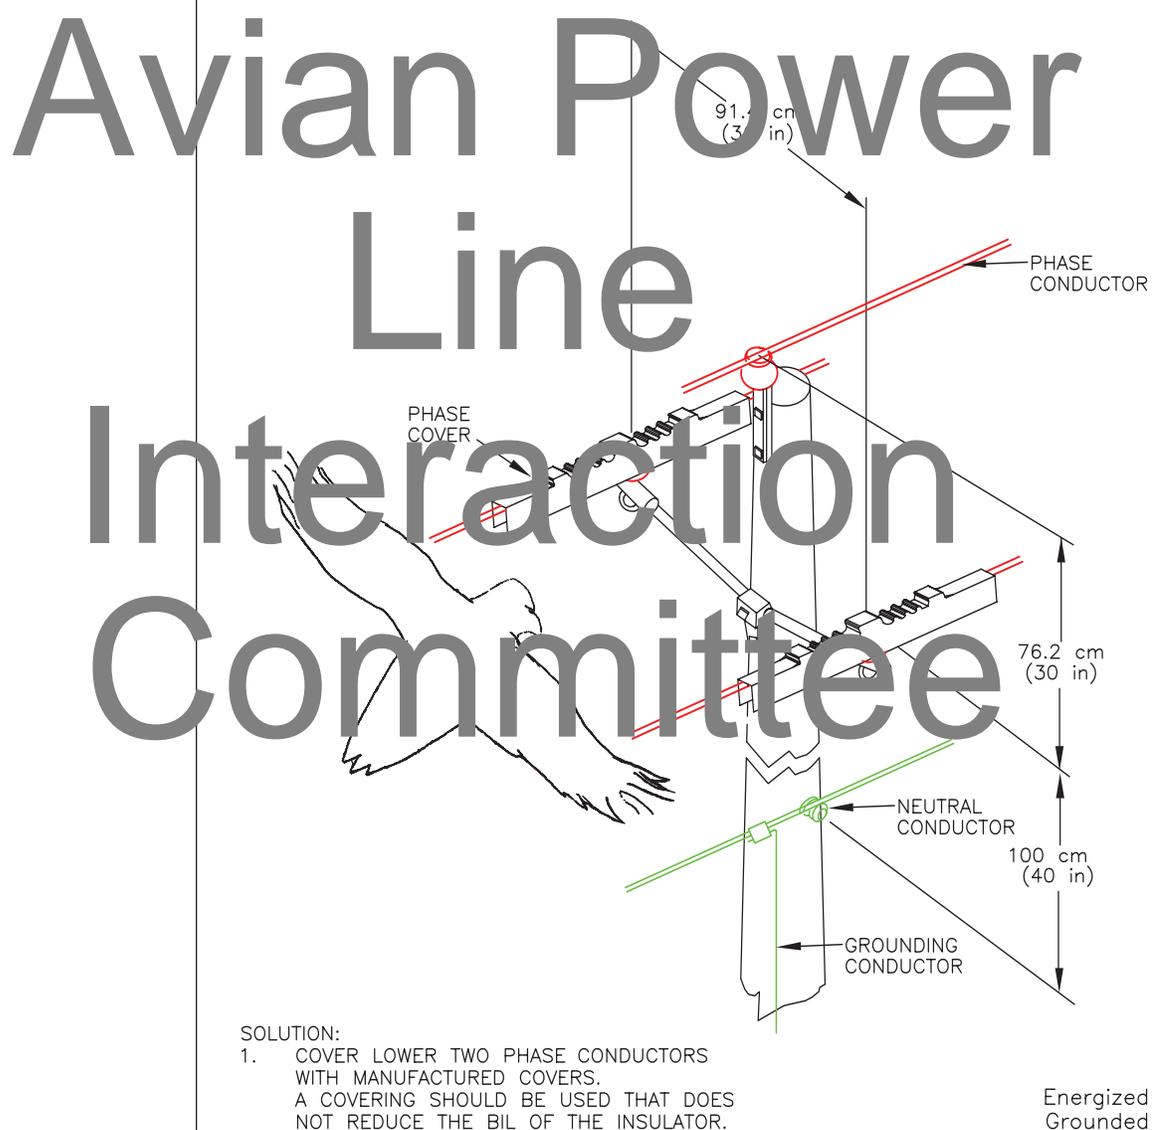
FIGURE 5.18: Solution for compact three-phase design.

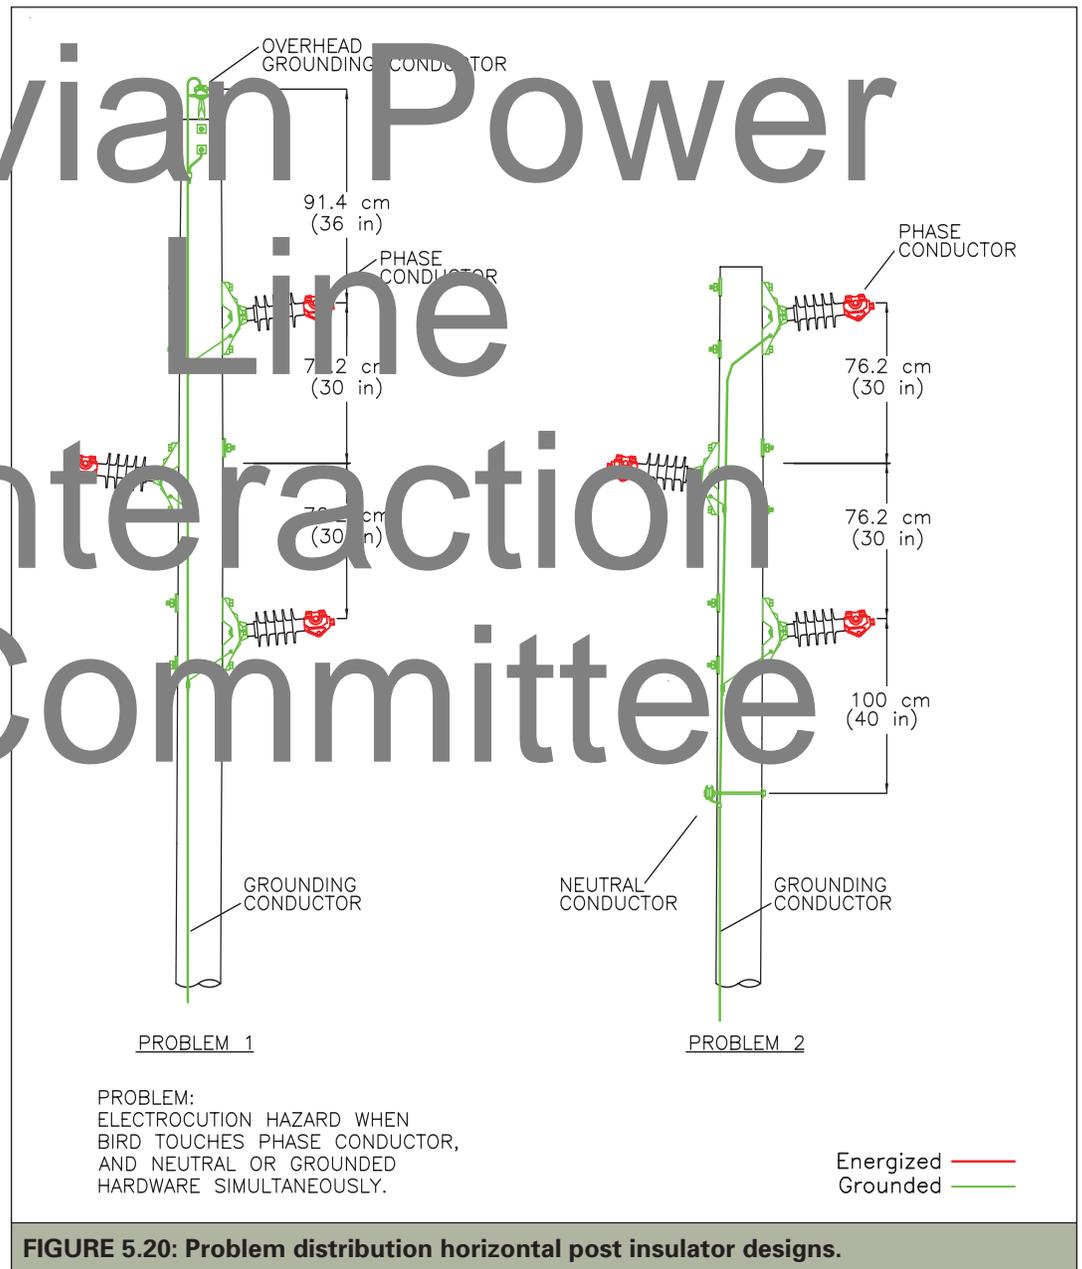
FIGURE 5.20: Problem distribution horizontal post insulator designs.

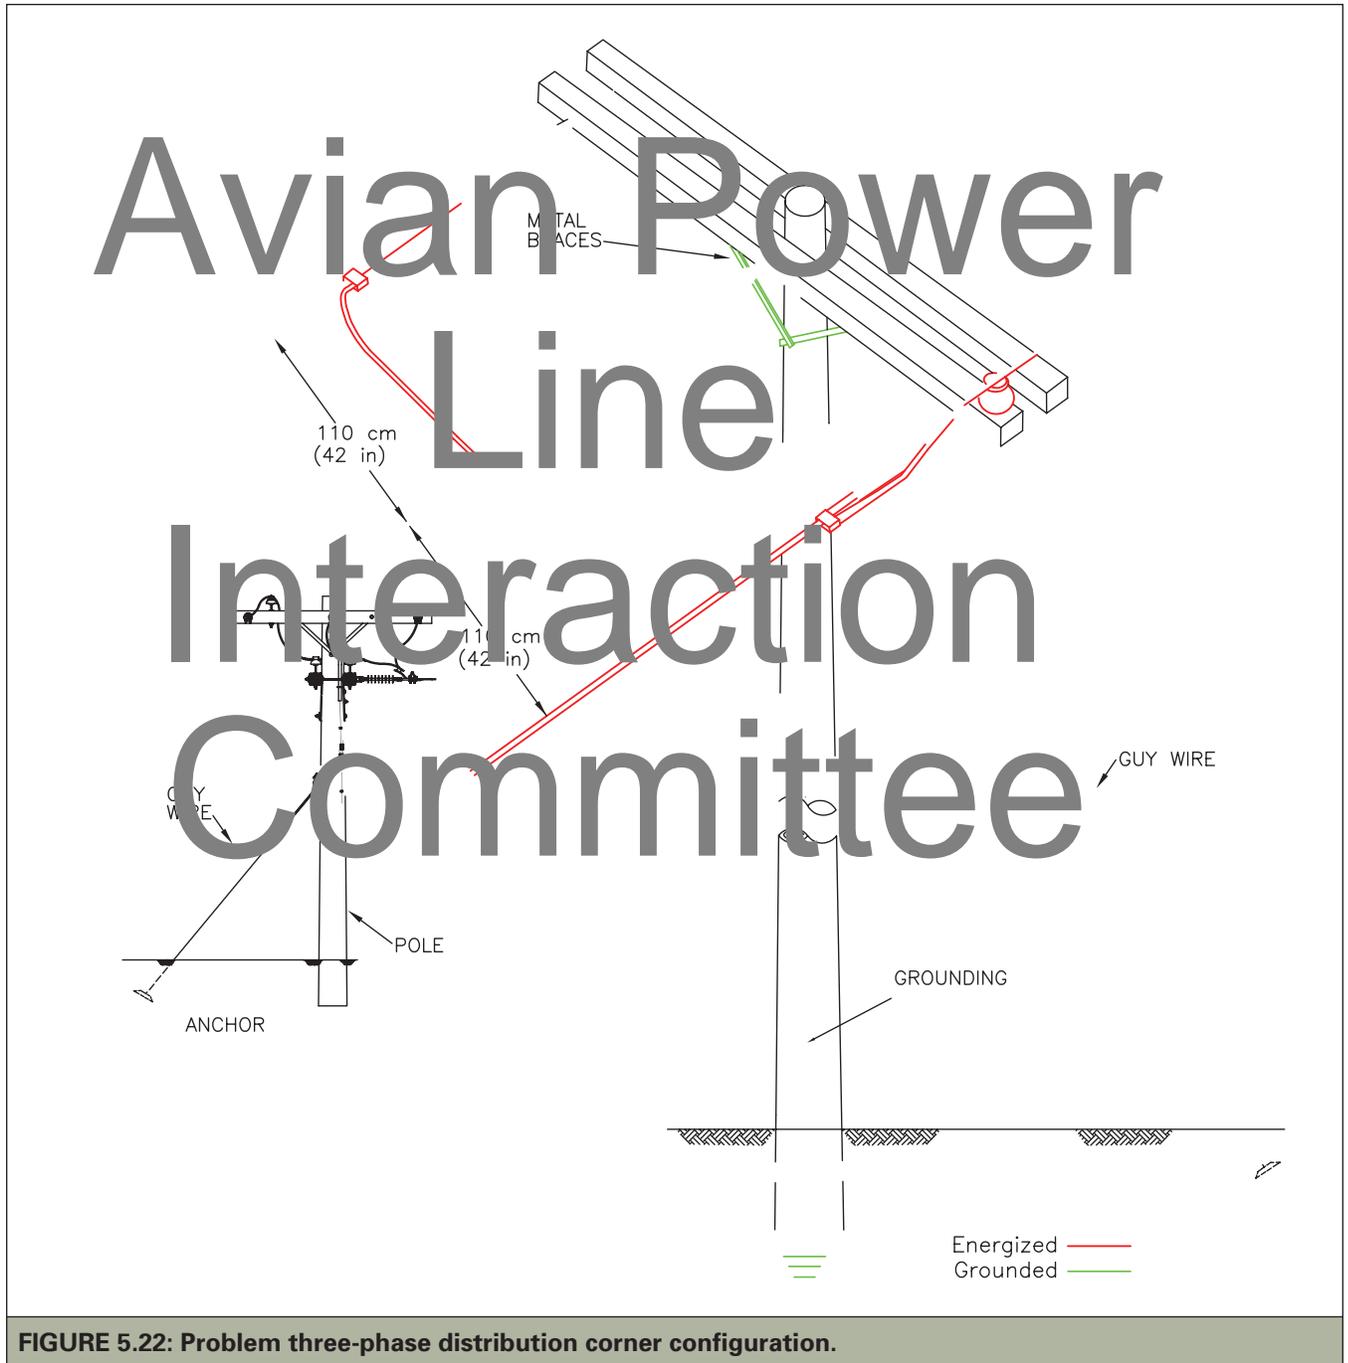
FIGURE 5.22: Problem three-phase distribution corner configuration.

On corner poles, the center phase conductor can be attached to the top set of crossarms with additional insulators or

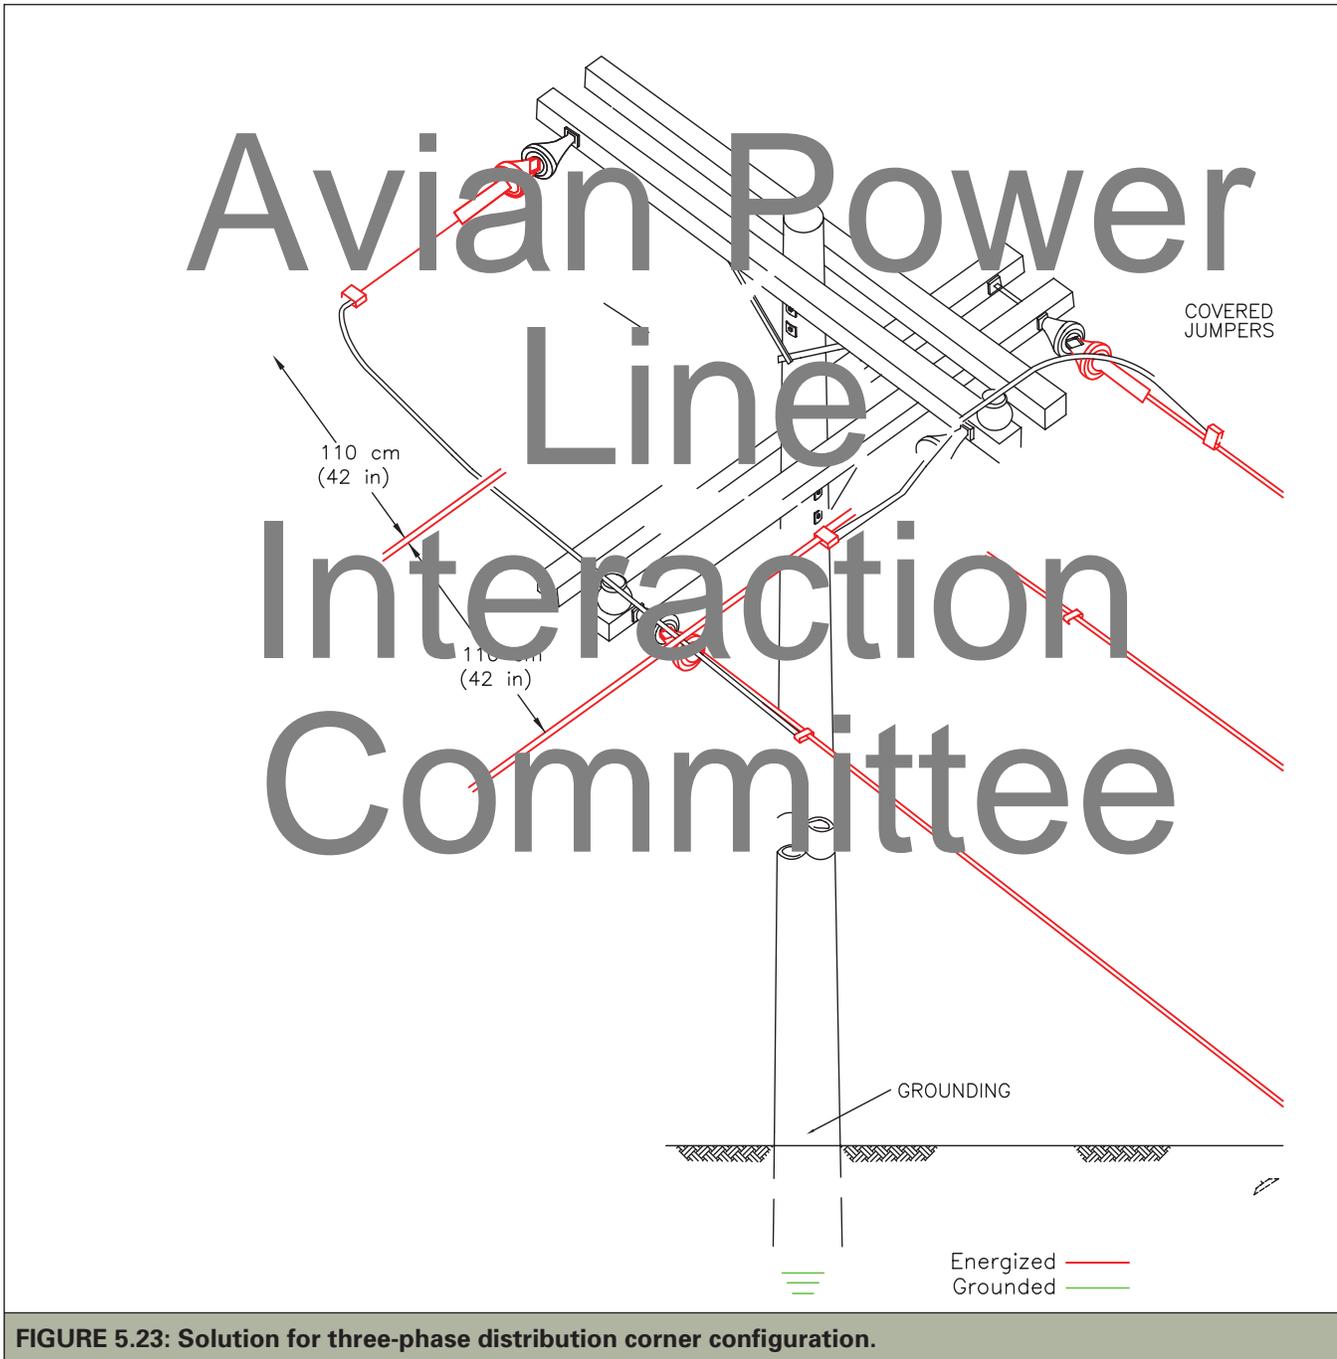
FIGURE 5.23: Solution for three-phase distribution corner configuration.

91 cm (36 in) from the pole to the conductor. Bare jumper wires should be covered with a material designed for the purpose or replaced with covered conductors. In addition, all down guy-wires should have guy strain

[8-ft] arms) that provide 150 cm (60 in) of phase-to-phase separation. Conventional corner poles can be constructed in the manner depicted in Figure 5.23. Other alternatives are the vertical designs shown in Figures 5.24

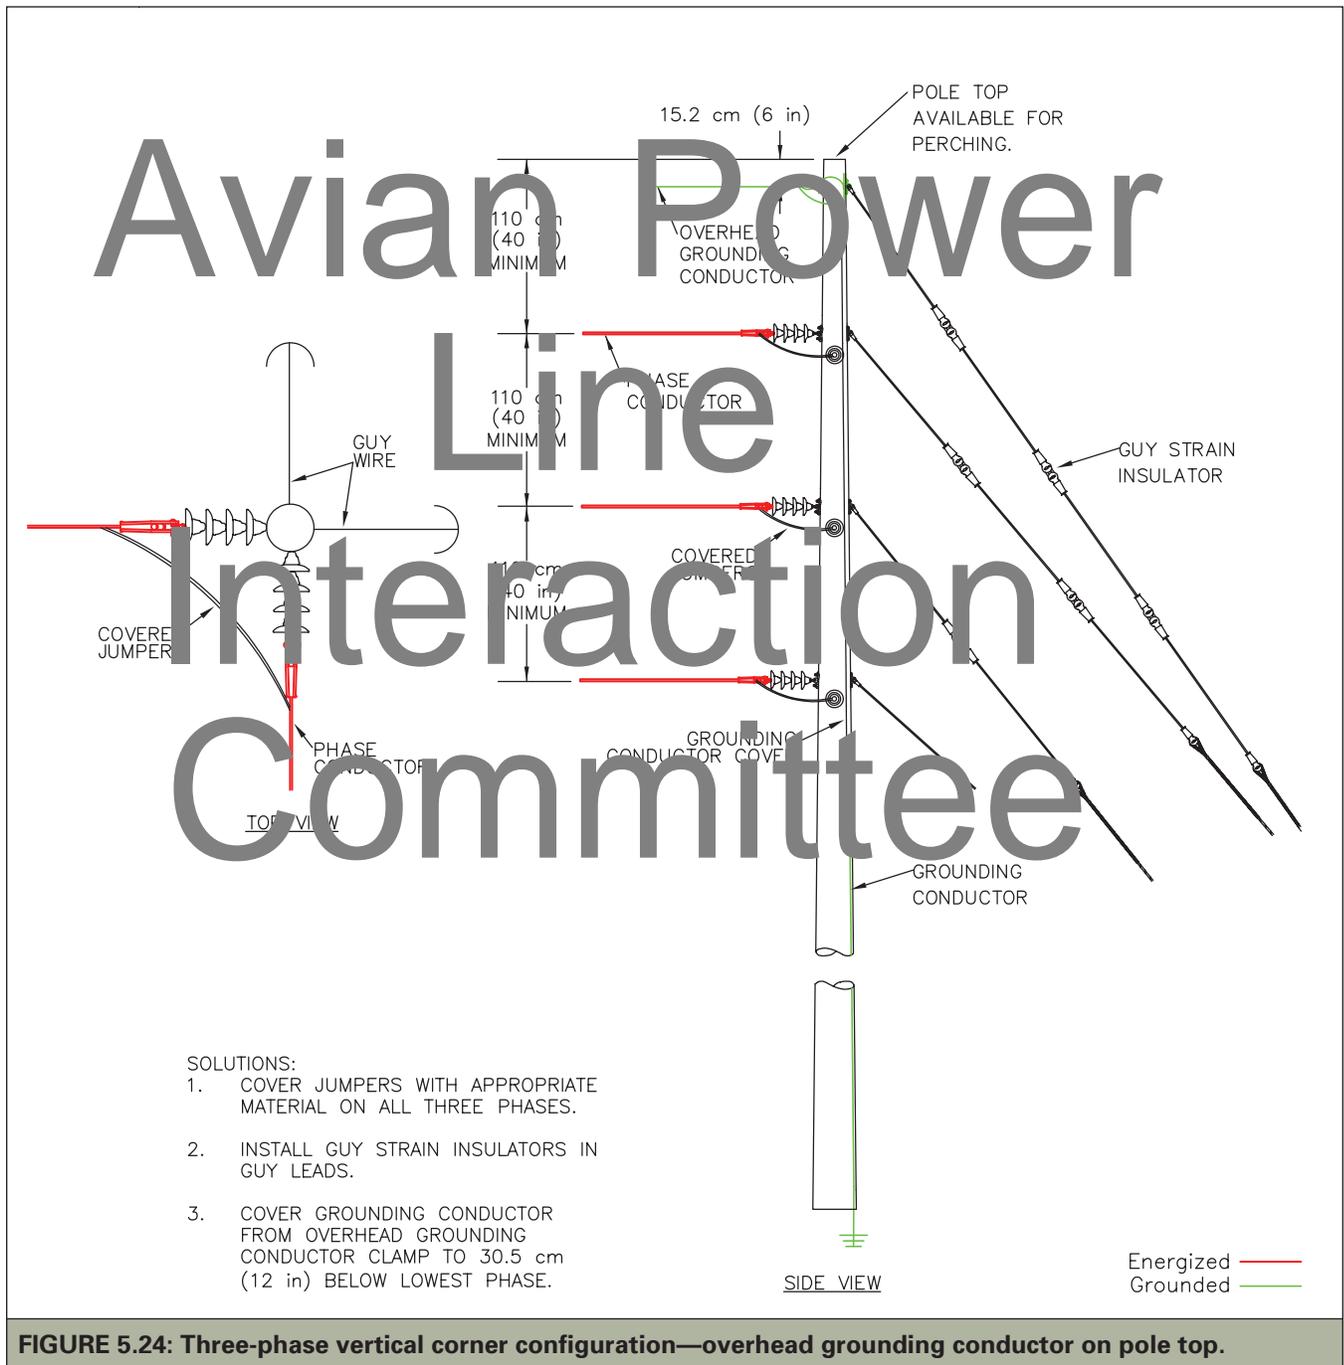
FIGURE 5.24: Three-phase vertical corner configuration—overhead grounding conductor on pole top.

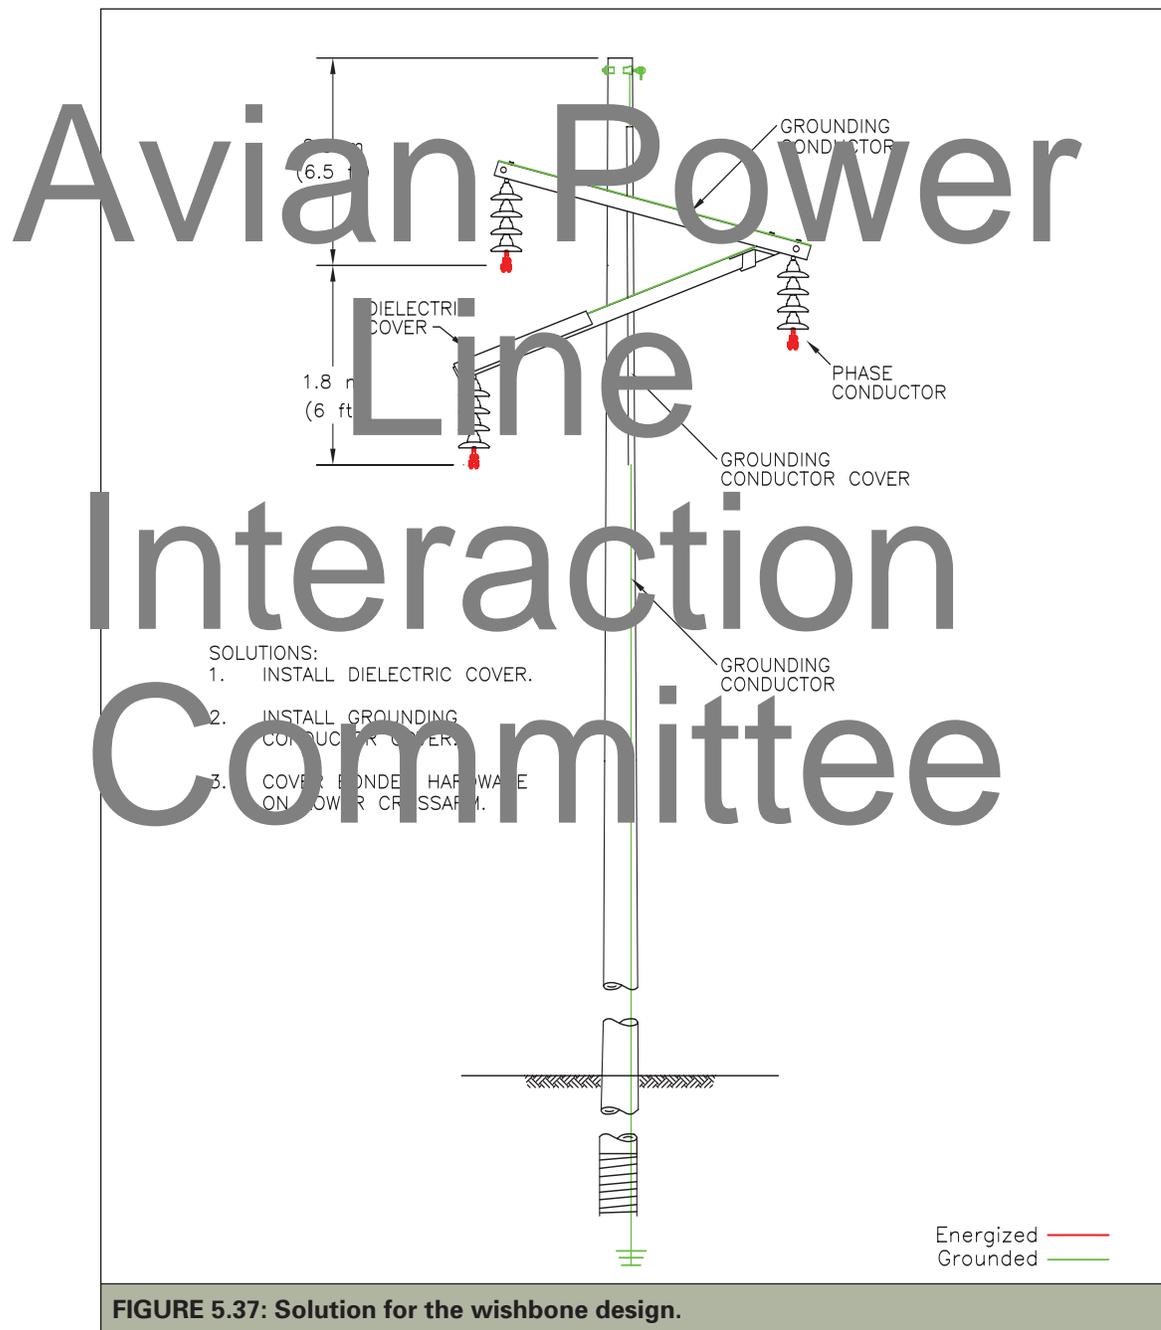
FIGURE 5.37: Solution for the wishbone design.

- installing a dielectric cover on the lower crossarm (Figure 5.37), and
- covering the grounding conductor with plastic or wood molding or plastic tubing. A covered ground wire may also be used. The grounding conductor should be

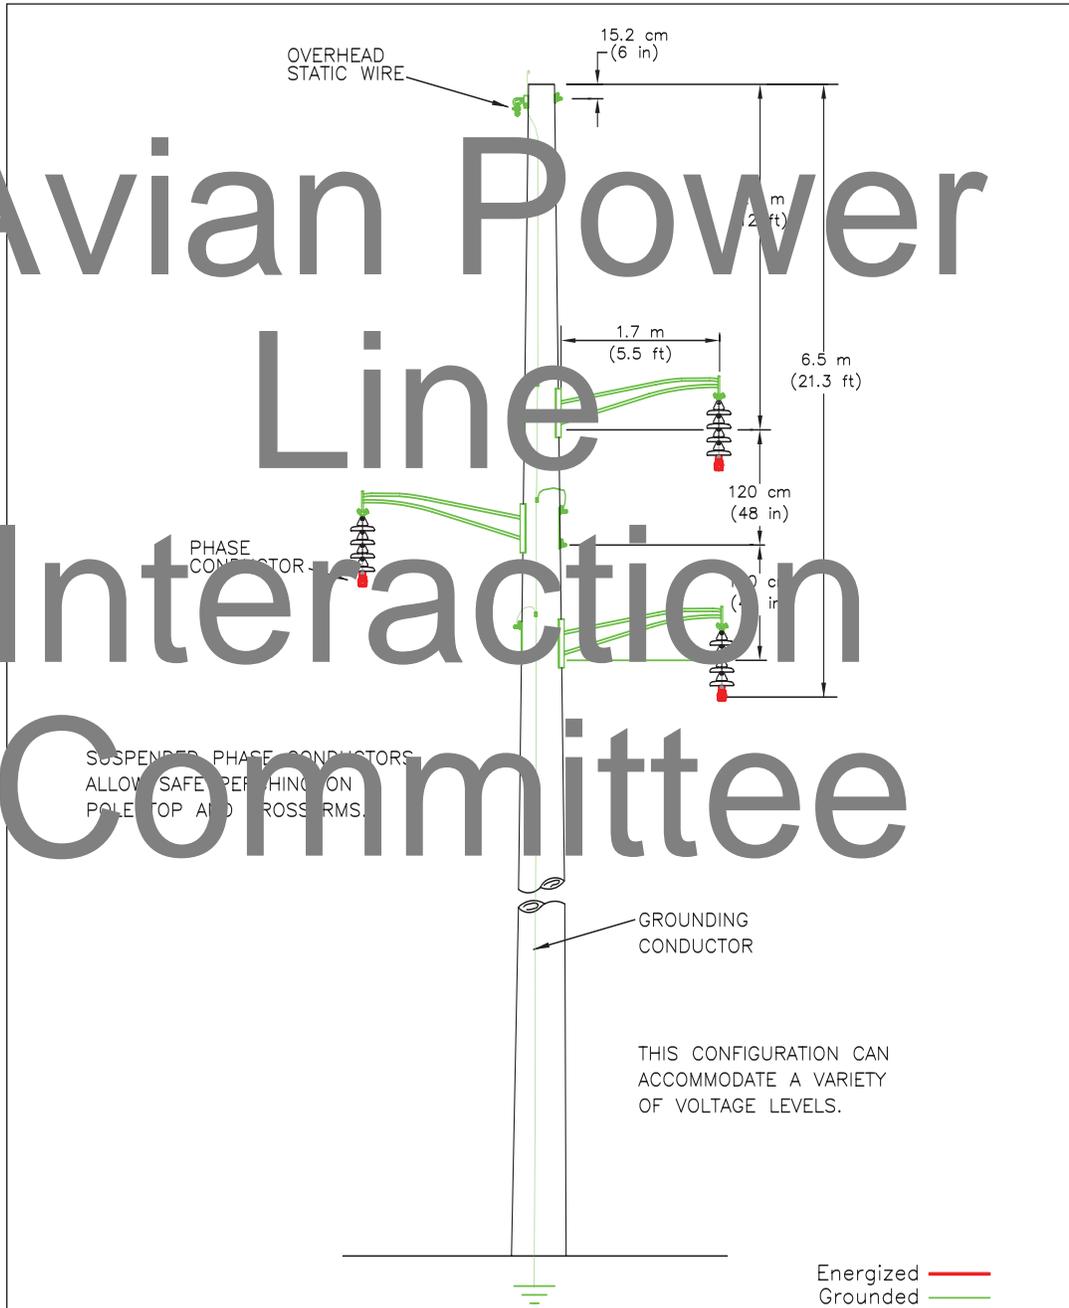
FIGURE 5.39: Avian-safe suspension configuration.

For new construction, a wishbone design that provides adequate separation for large birds can be used (Figure 5.38). An avian-safe suspension configuration (Figure 5.39) can also be used for new construction as an

alternative to the wishbone or horizontal post designs. This suspension configuration provides adequate separation between phases and accommodates perching on the davit arms. The ridge pin overhead-grounding conductor

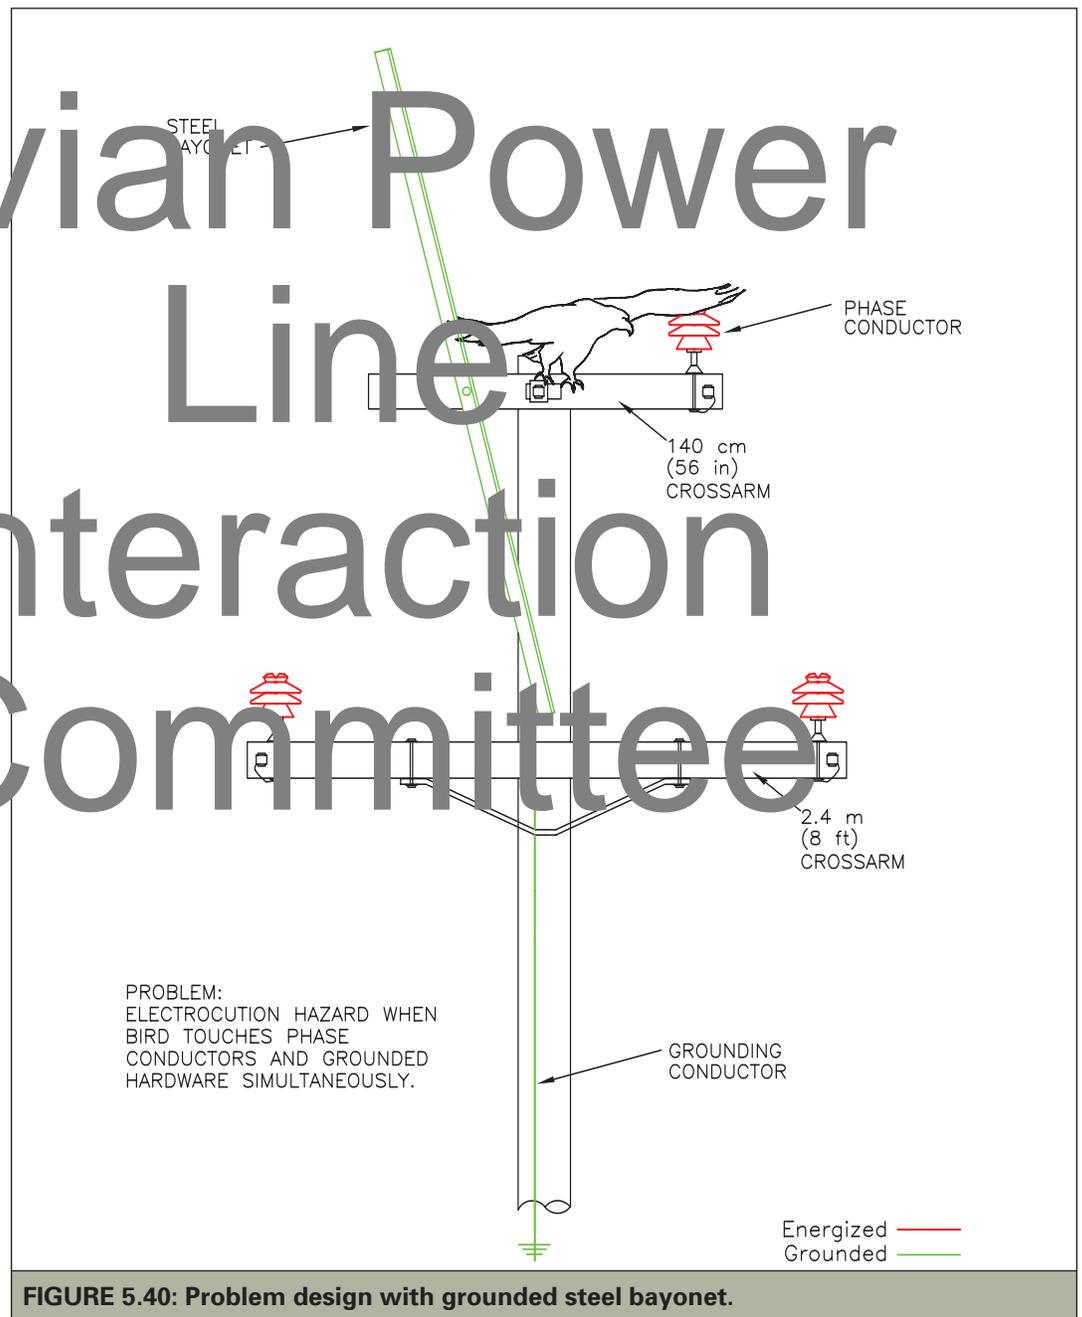
FIGURE 5.40: Problem design with grounded steel bayonet.
