Suggested Practices for Avian Protection On Power Lines:

The State of the Art in 2006

Avian Power Line Interaction Committee

PIER FINAL PROJECT REPORT CEC-500-2006-022

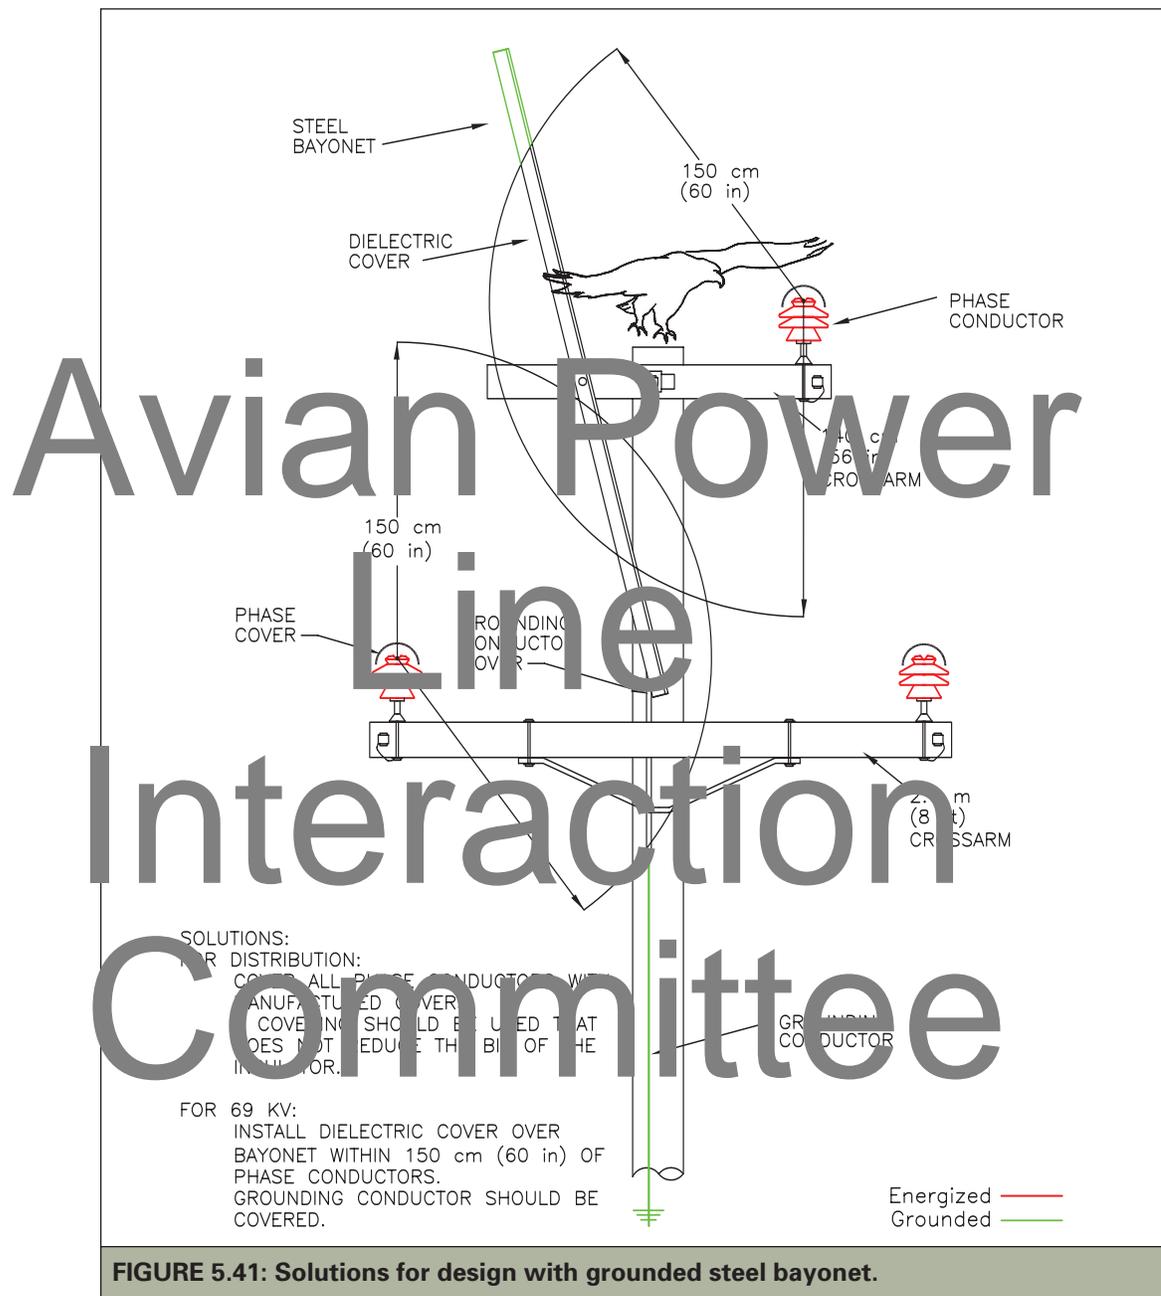
FIGURE 5.41: Solutions for design with grounded steel bayonet.

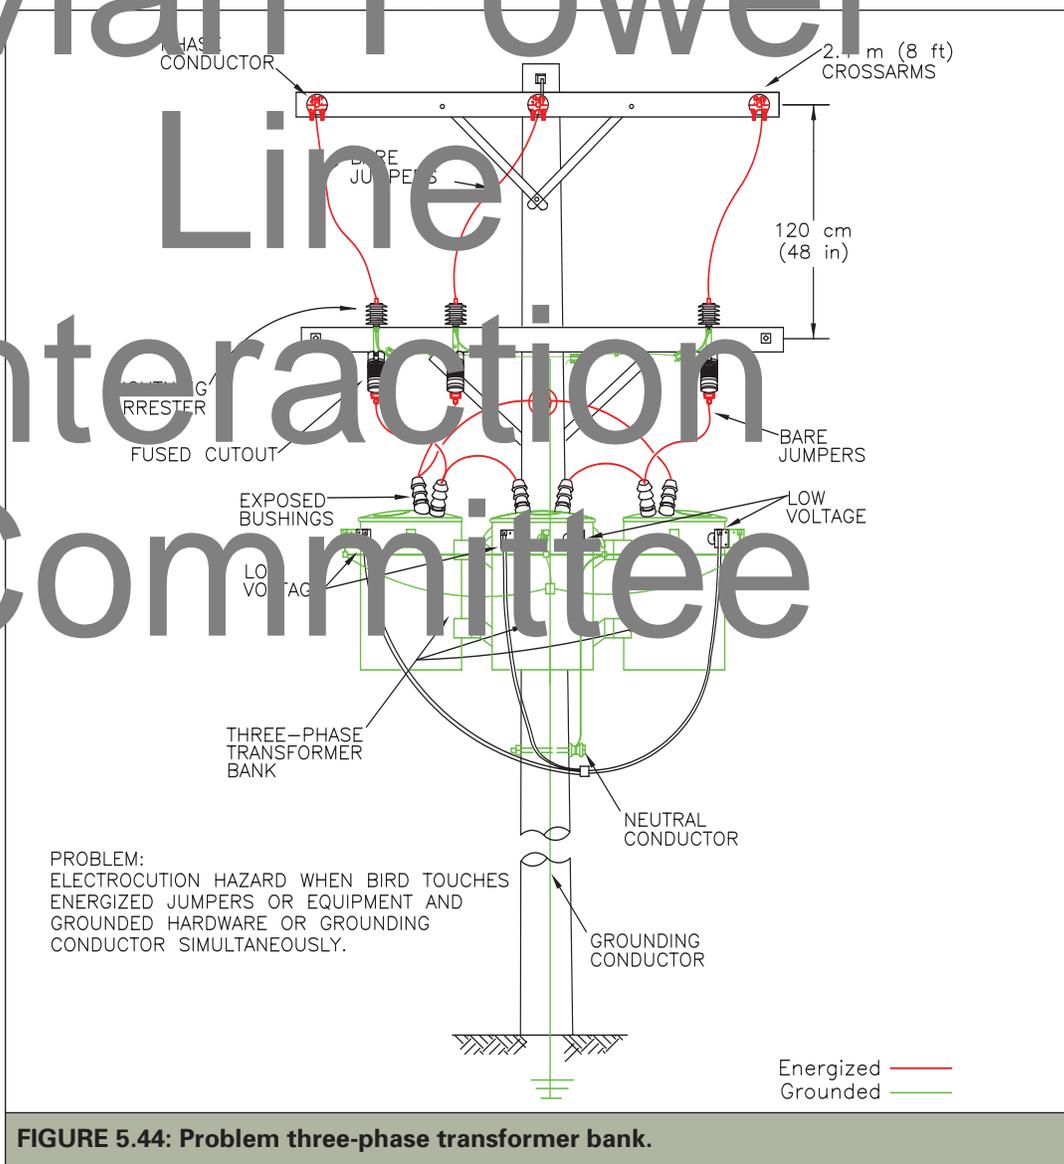
FIGURE 5.44: Problem three-phase transformer bank.

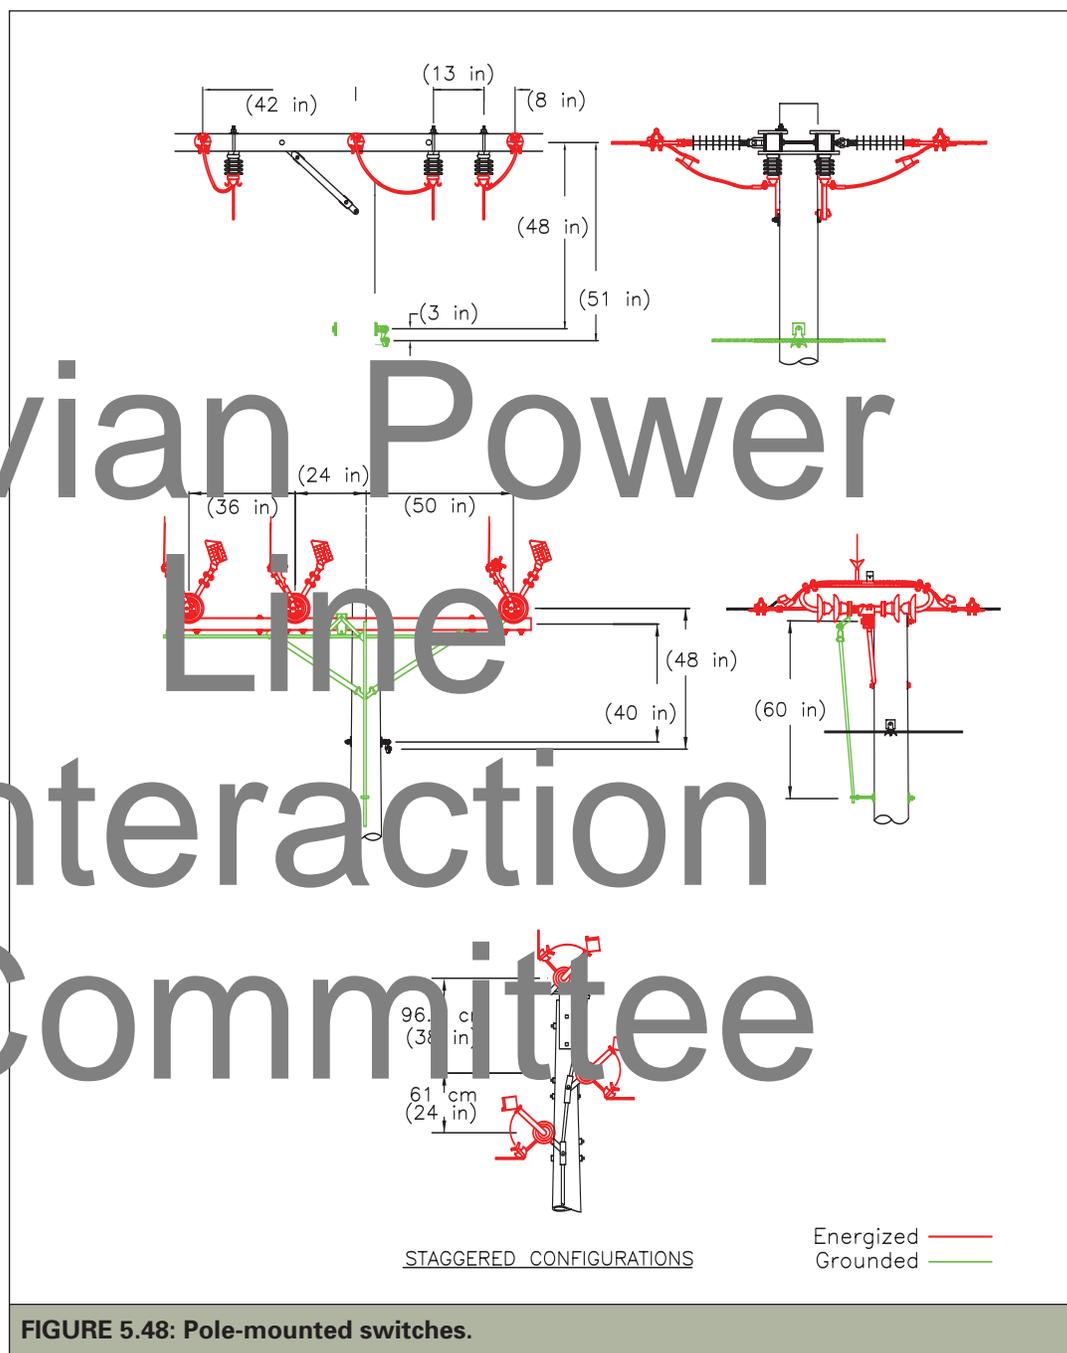
FIGURE 5.48: Pole-mounted switches.

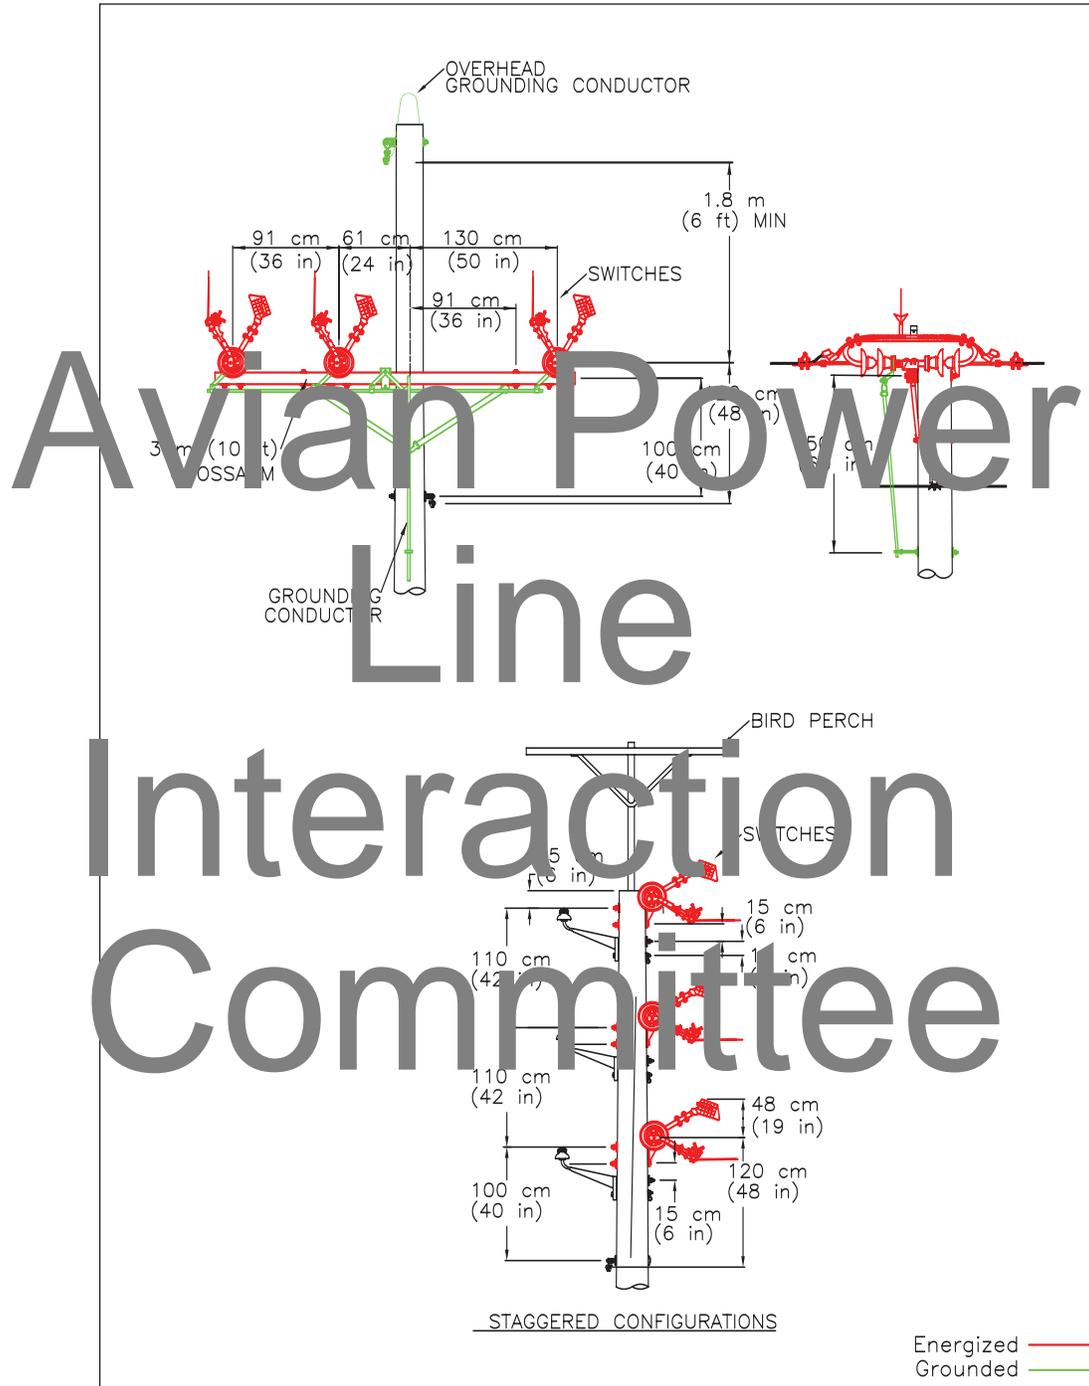
FIGURE 5.49: Pole-mounted switches.

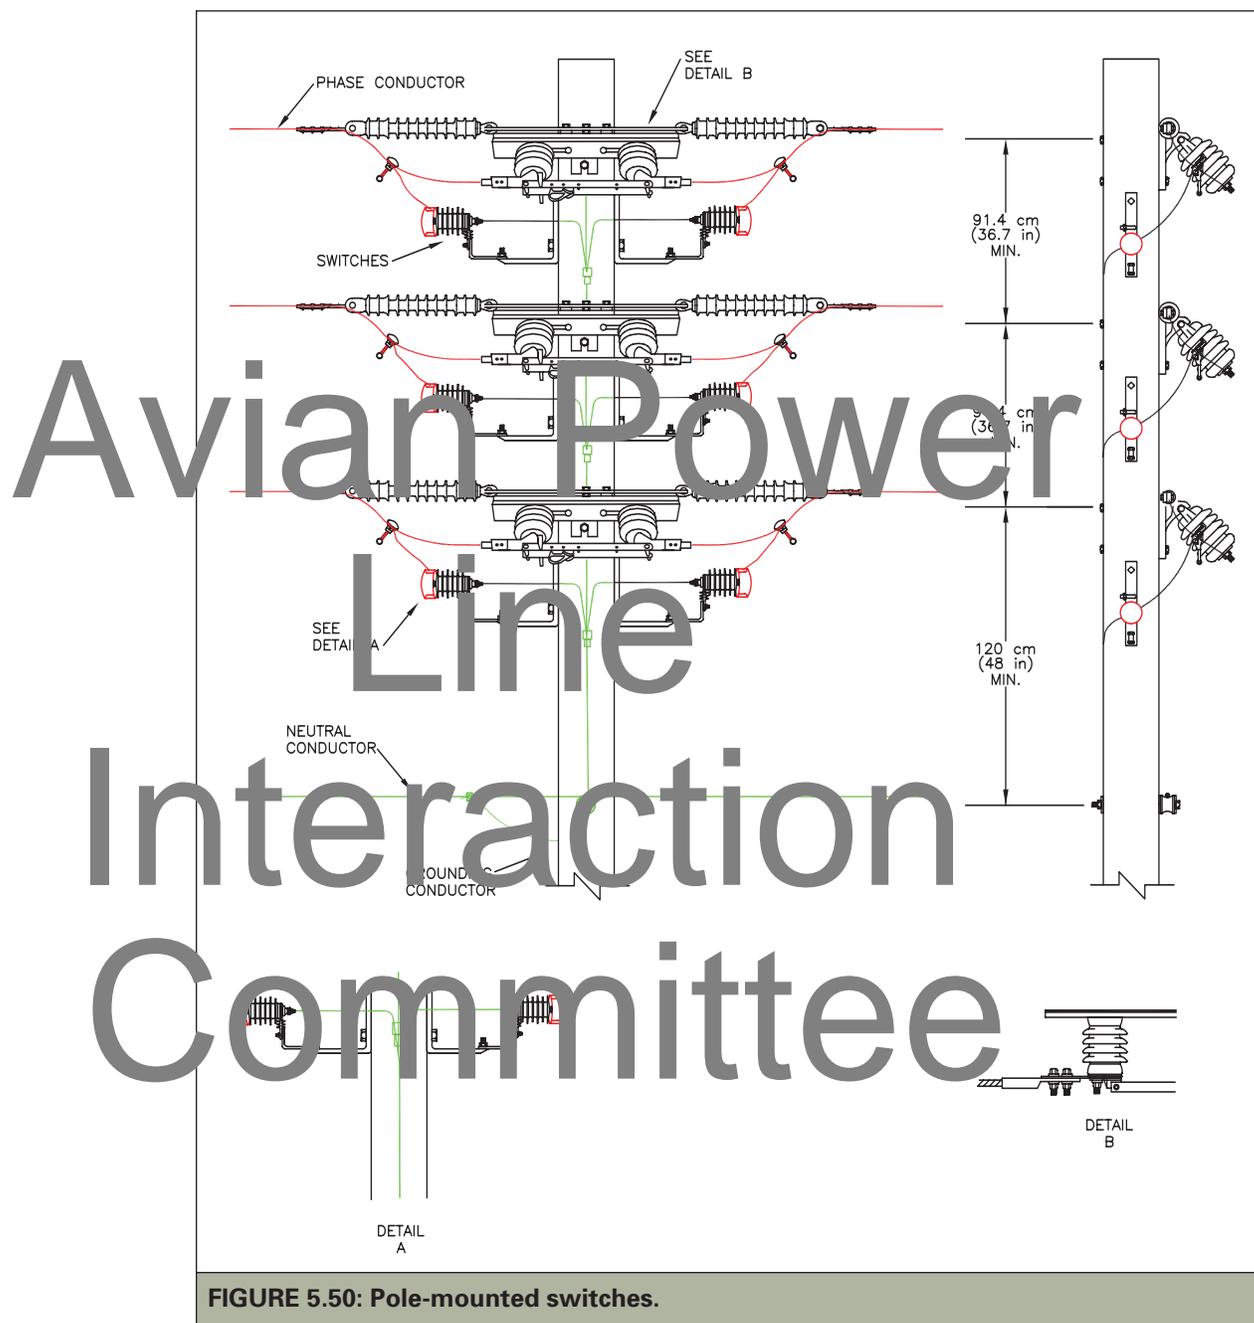
FIGURE 5.50: Pole-mounted switches.

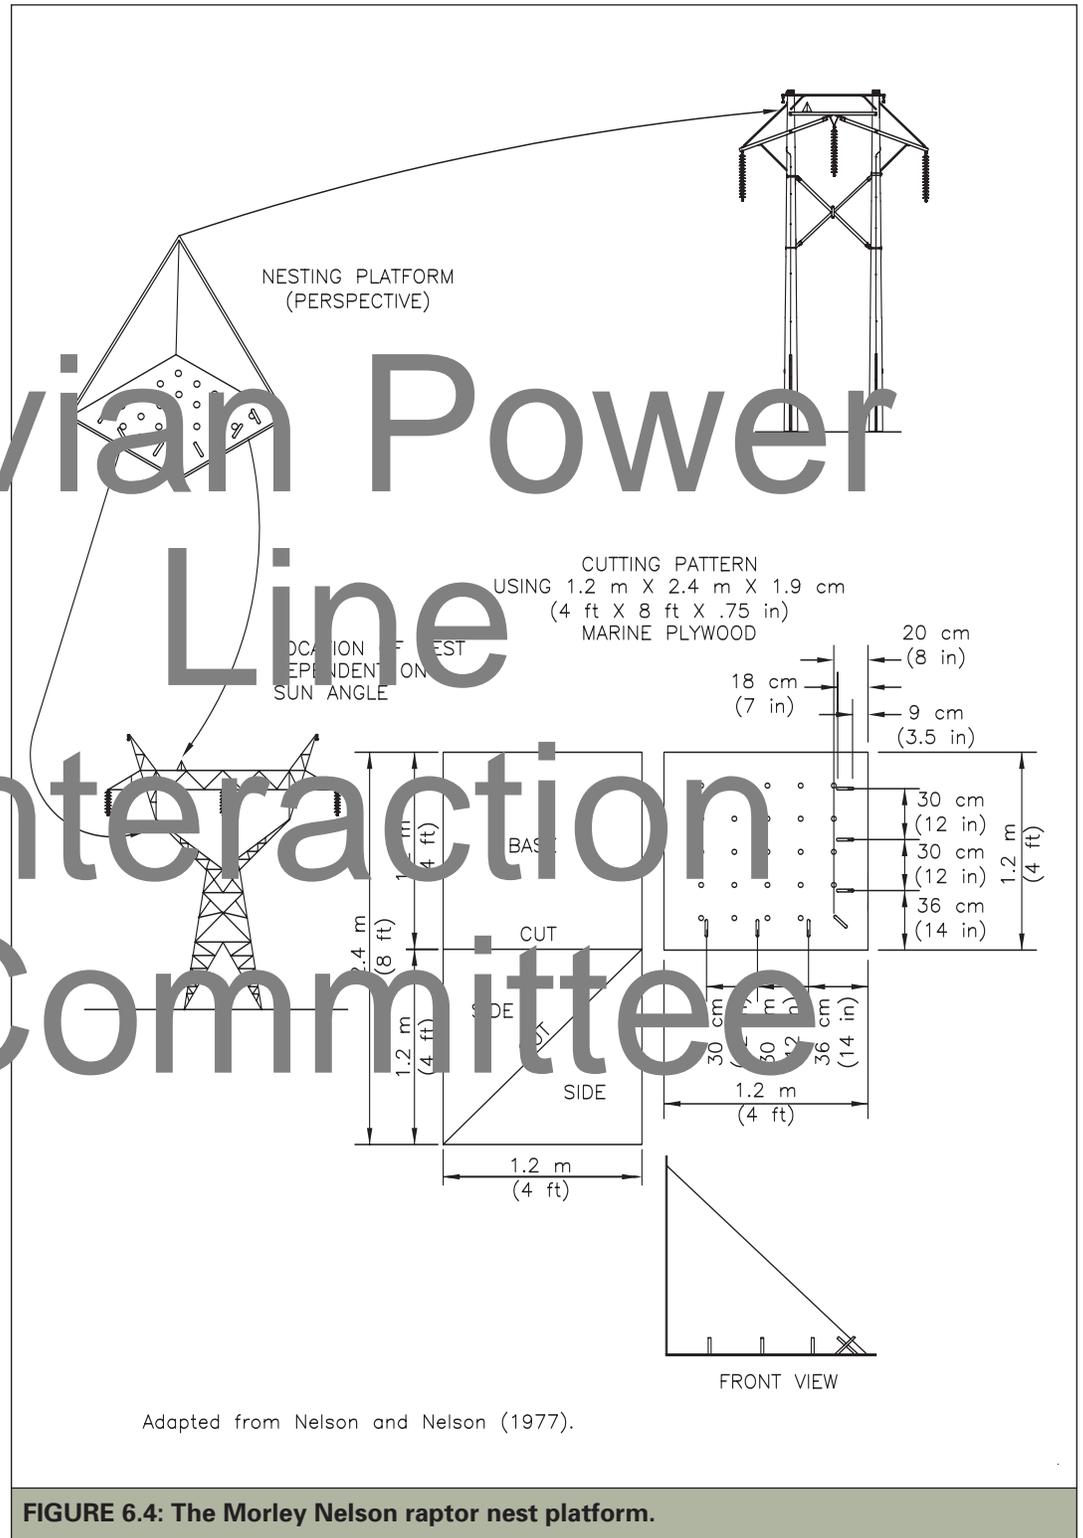
FIGURE 6.4: The Morley Nelson raptor nest platform.

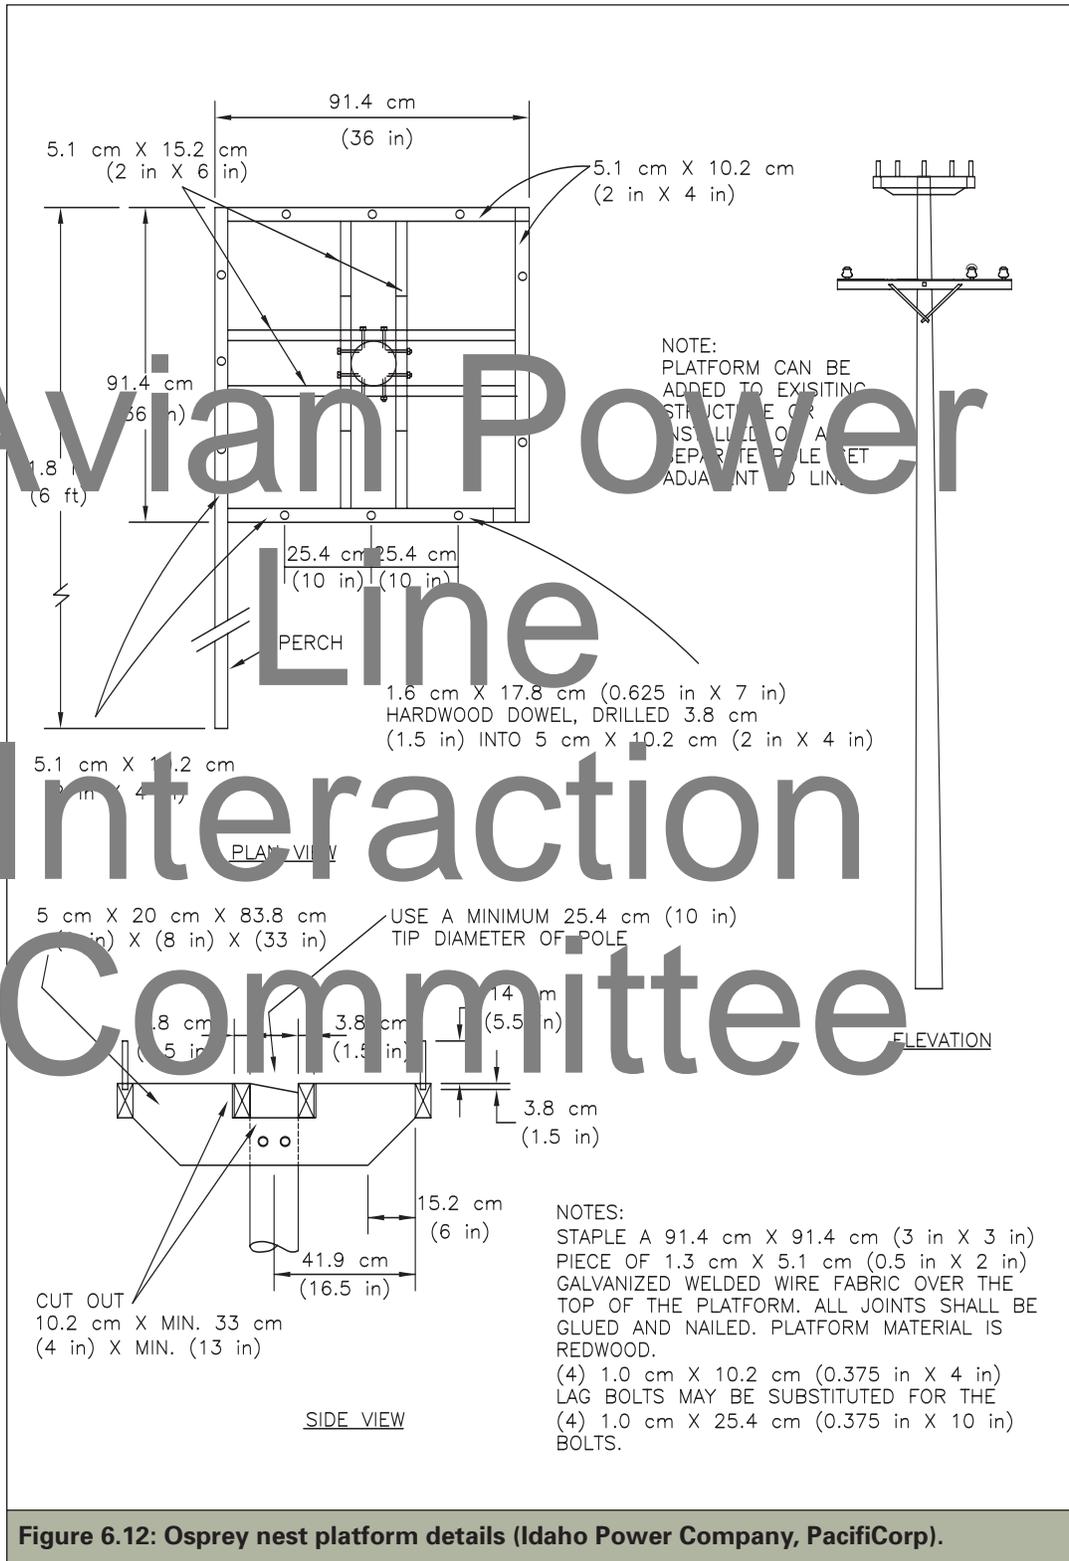
Figure 6.12: Osprey nest platform details (Idaho Power Company, PacifiCorp).

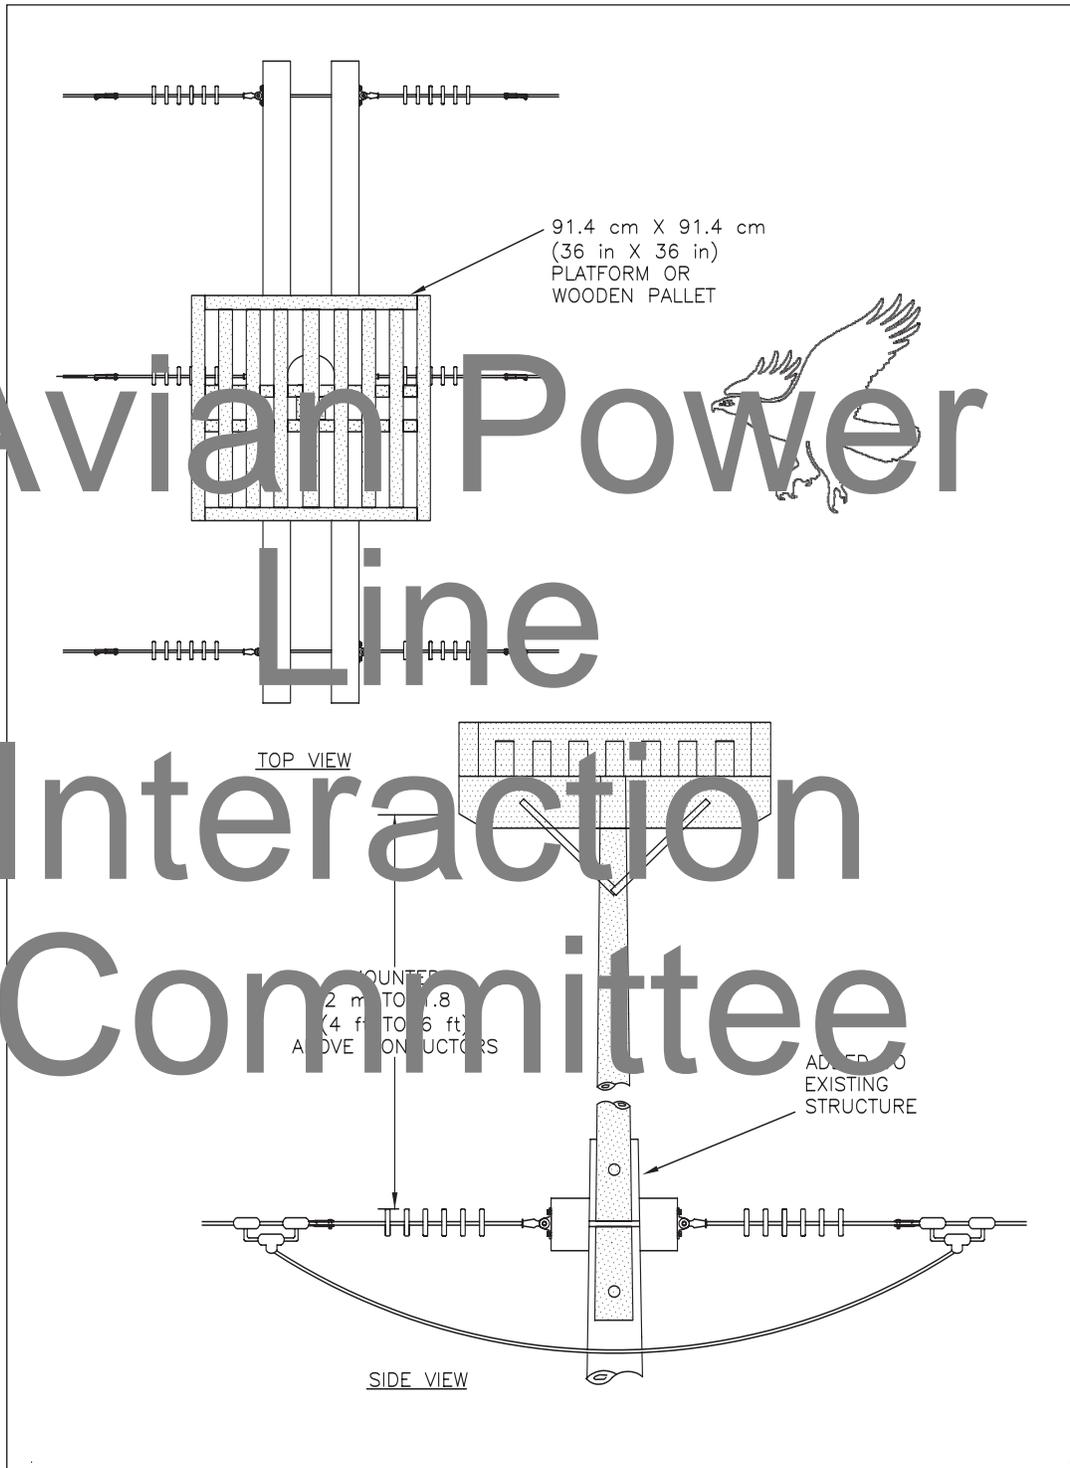
FIGURE 6.15: Raptor nest platform used by ospreys and some buteos (PacifiCorp). This design is recommended when a new nest pole cannot be erected.

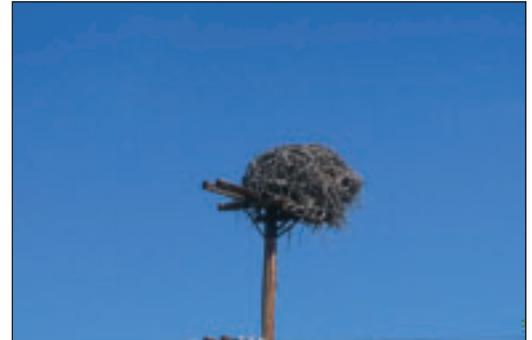
FIGURE 6.16: Osprey nest in Wyoming atop double dead-end pole. Nesting material that may drop onto the conductors or equipment poses fire, outage, and equipment damage risks.

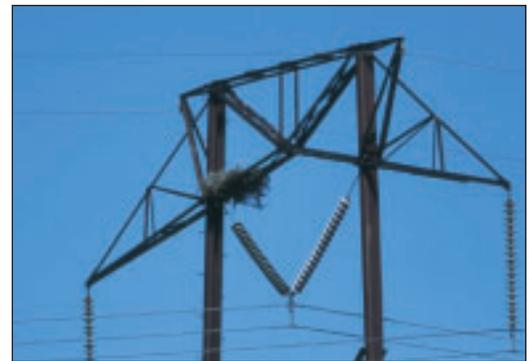
FIGURE 6.17: Golden eagle nest on transmission tower.

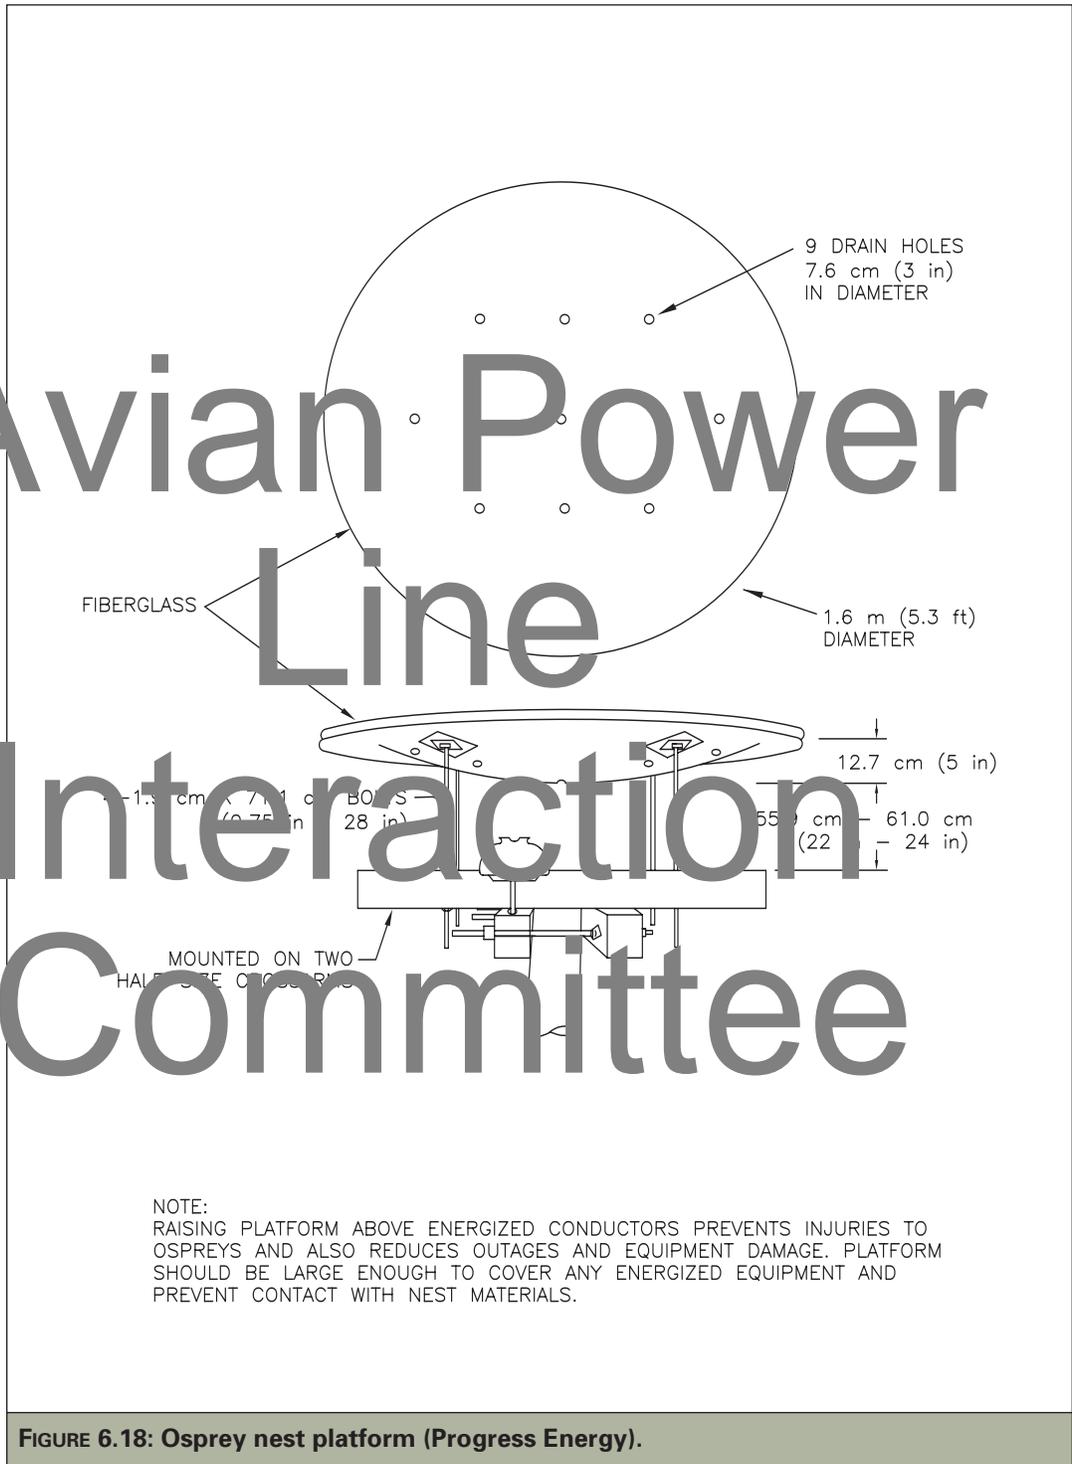
FIGURE 6.18: Osprey nest platform (Progress Energy).

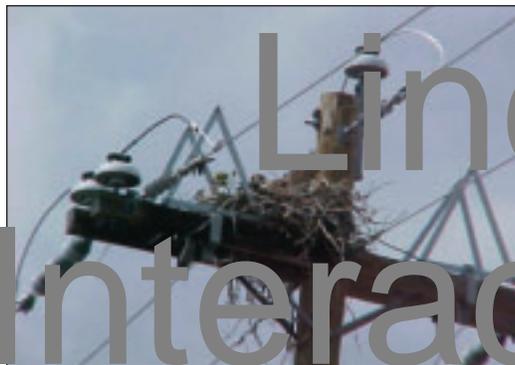
FIGURE 6.25: Red-tailed hawk nest on pole with triangle perch discouragers.
