**Historic Building Assessment of the  
Chemistry and Metallurgy Research (CMR) Building (TA-3-29)**

Historic Building Survey Report No. 280

**Los Alamos National Laboratory**

**July 17, 2009  
Survey No. 1052**

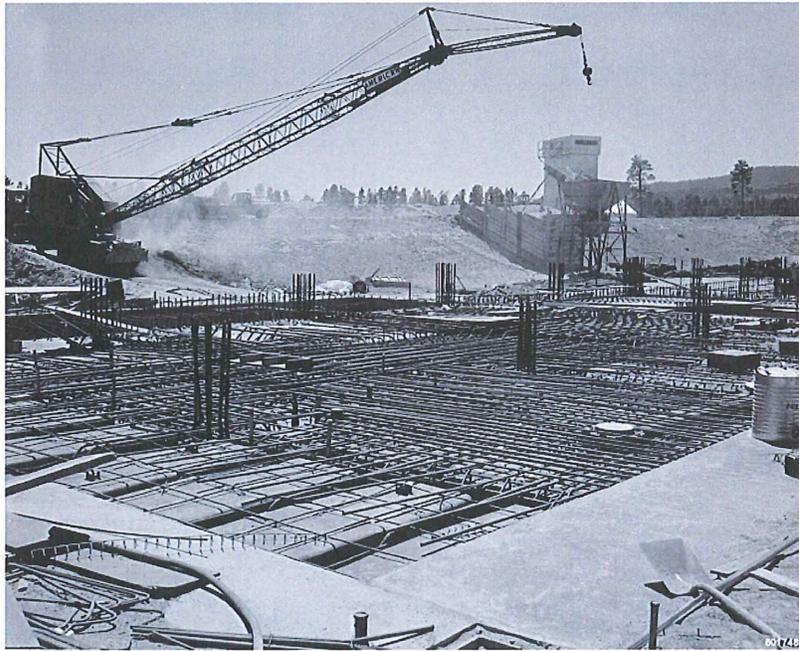
The CMR Building was constructed in compliance with the standards in effect during the early 1950s. At the time it was built, the building contained state-of-the-art instrumentation, ventilation, and safety controls. Figures 5 and 6 depict the degree to which steel reinforcement and concrete is integral to the construction of the facility. According to an unconfirmed account, the CMR Building represented the largest concrete facility in the state of New Mexico at the time of its completion.

Figure 5. 1952 construction close up; showing concrete and steel reinforcement

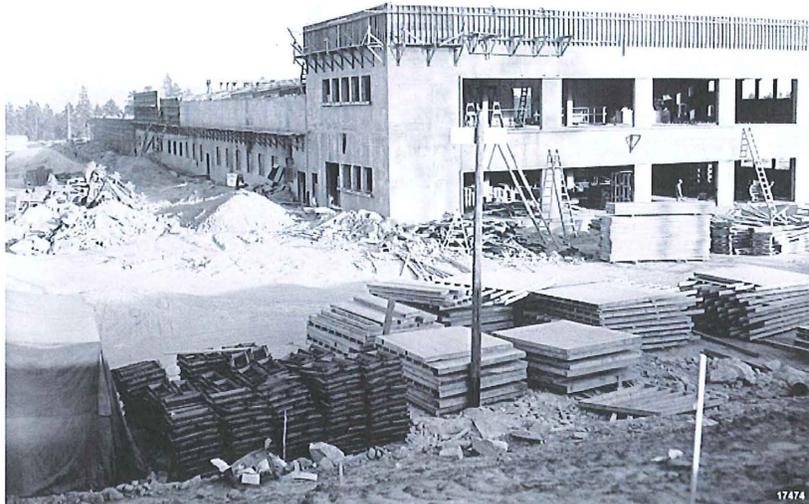
Figure 6. 1952 construction of Wing 2 (foreground), looking northwest

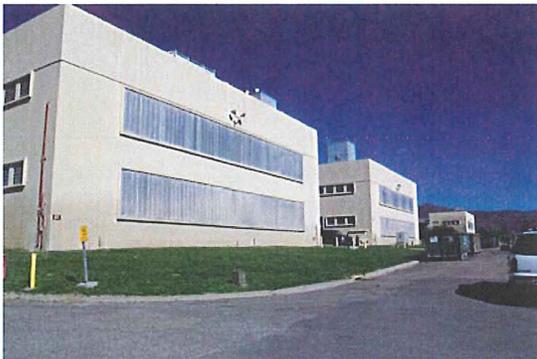
East side of Wings 7, 3, 2 (near to far) looking north (note: silver colored panels are blow-out panels)

Large equipment rooms are constructed at the east and west ends of each of the four wings. The long end walls of these rooms (east and west) are equipped with aluminum blow-out panels while the north and south walls of these rooms are equipped with glass block panels. The north walls of the equipment rooms in Wings 2 and 4 are also equipped with an overhead door, raised concrete dock, and single, painted hollow metal door. The same is true for the south side of the equipment rooms for Wings 3 and 5. Two more painted hollow-metal egress doors are spaced along the north and south elevations of each wing. Wing 1 has a pair of hollow-metal doors and a raised concrete dock on the west side. Besides the glass block panels, windows are primarily limited to the first floor of each wing and the second floor of the corridor behind the Administration Wing.

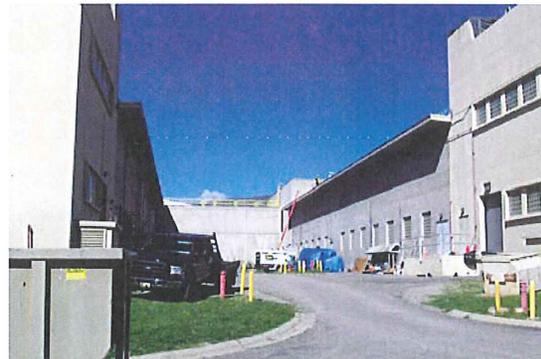
East side of central corridor (center) and area between Wings 7 (left) and Wing 3 (right)

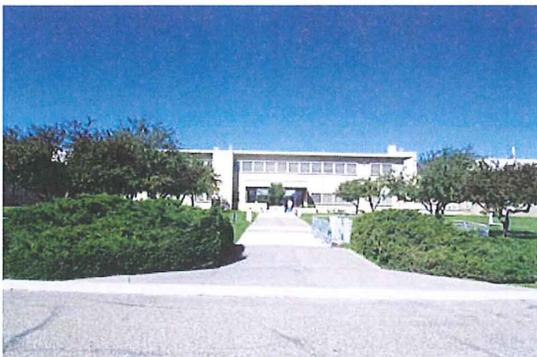
East side of main entrance – Administration Wing

The main entrance is located on the east side of Administration Wing and consists of a vestibule outfitted with aluminum storefront doors and glass block, covered projected landing, and concrete steps.

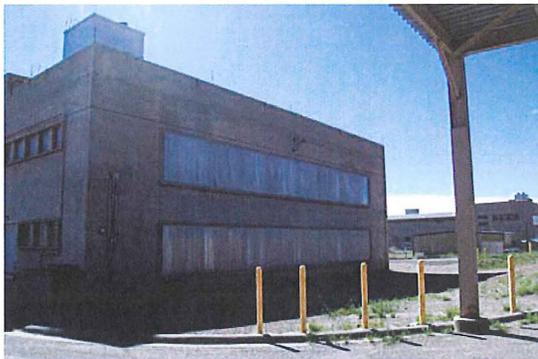
West side of Wing 4. Note blow-out panels and glass block panels on the north side (left)

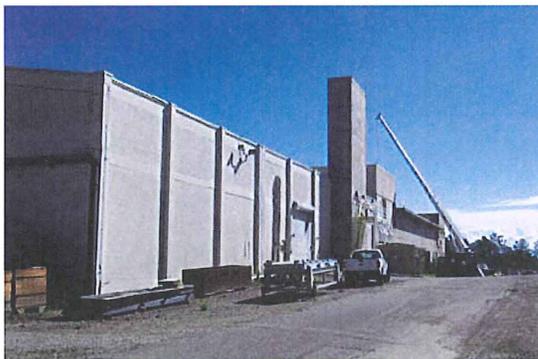
South side of Wings 9 (near with stack) and 7 (far) looking east

Wing 9 was constructed to the west of Wing 7 in 1960. The wing was built using a concrete post and beam structural system with concrete block infill panels. Wing 9 has a

low-pitched broken gable roof, and a 3-story vent stack is located on its south side. The wing has a different layout than the other wings due to its use for remote handling work with highly radioactive materials. The west elevation of this wing is equipped with both single and double hollow metal doors. Instead of a raised dock, the doors have concrete steps.
